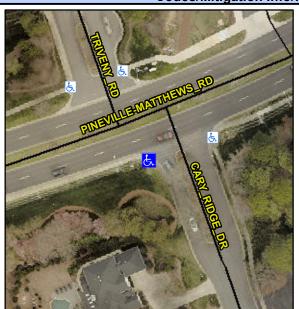
Intersection ID: 25795 Main Street: PINEVILLE-MATTHEWS_RD Cross Street: CARY_RIDGE_DR Location: S

Total Cost: \$ 1850.00

Field Measurements/Component Compliance						
Compl	liance Description	Data	Comp	liance Description	Data	
N/A	Ramp Length (in)	59.0	No	Ramp Slope (%)	14.0	
No	Ramp Width (in)	44.0	No	Ramp XSlope (%)	2.4	
N/A	Flare Type LT	N/A	N/A	Flare Type RT	N/A	
N/A	Flare Slope LT (%)	N/A	N/A	Flare Slope RT (%)	N/A	
N/A	Flare Traversable LT?	N/A	N/A	Flare Traversable RT?	N/A	
N/A	Landing Length (in)	N/A	N/A	DWS Provided?	N/A	
N/A	Landing Width (in)	N/A	N/A	DWS Contrast?	N/A	
N/A	Landing Slope (%)	N/A	N/A	DWS Length (in)	N/A	
N/A	Landing X Slope (%)	N/A	N/A	DWS Full Width?	N/A	
N/A	Landing Curb? (Y/N)	N/A	N/A	DWS Offset (in)	N/A	
N/A	Shared Landing?	N/A				
N/A	Gutter Ponding?	N/A	N/A	Gutter Slope (%)	N/A	
N/A	Gutter Lip Ht (in)	N/A	N/A	Gutter X Slope (%)	N/A	
N/A	Painted X Walk1?	No	N/A	Painted X Walk2?	N/A	
	X Walk 1 Direction	To E		X Walk 2 Direction	N/A	
N/A	X Walk 1 Width (in)	N/A	N/A	X Walk 2 Width (in)	N/A	
	X Walk 1 Slope (%)	1.0		X Walk 2 Slope (%)	N/A

Street 1 Name
CARY RIDGE DR
Stop Condition-Street 2
StopSign
Street 2 Name
N/A
Stop Condition-Street 1
N/A
