Access Compliance Report

Public Rights-of-Way

| Intersection ID: 15243 | Main Street: ALBEMARLE_RD | Cross Street: REGAL_OAKS_DR | Location: SW |
| ADA ID: 08CFEBE0DCEA | Ramp Type: PerpDiag | Initial Pass/Fail: Fail | Overall Compliance: No |

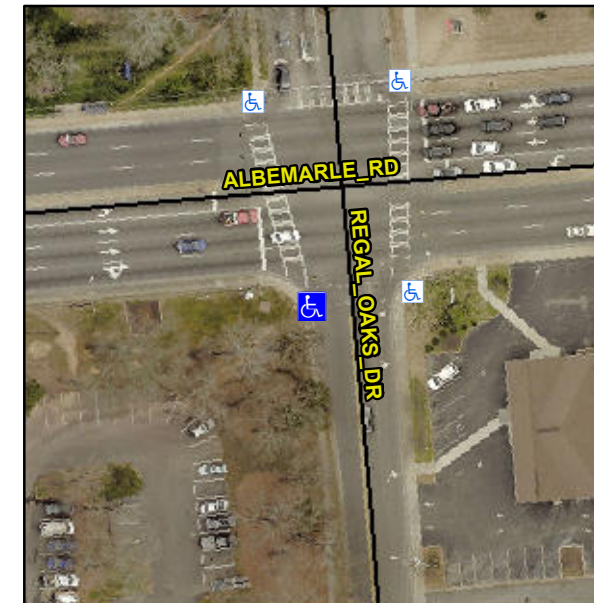
Not Found, R304.2.2

| Compliance | Description | Data | Compliance | Description | Data |
|---|---|---|---|---|---|
| N/A | Ramp Length (in) | 58.5 | No | Ramp Slope (%) | 9.4 |
| N/A | Gutter Lip Ht (in) | 1.5 | N/A | Gutter X Slope (%) | N/A |

Remove & Replace Curb Ramp With Two New Directional Ramps or Equivalent.
