Access Compliance Report

Public Rights-of-Way

(Curb Ramps)

Intersection ID: 25150	Main Street: MEADOWRIDGE_DR	Cross Street: WINBURN_LN	Location: S
ADA ID: 08D4846CFB47	Ramp Type: Perp	Initial Pass/Fail: Fail	Overall Compliance: No
Severity Score: 21.25			
Codes/Mitigation Info/Possible Solution		Field Measurements/Component Compliance

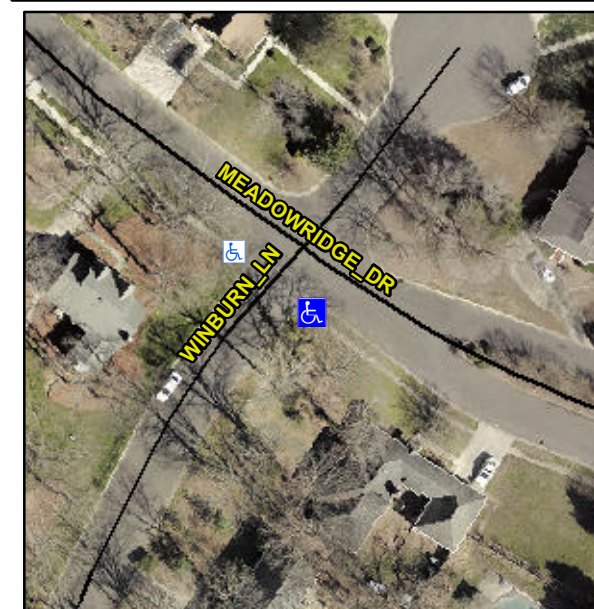
Not Found, R304.5.1, R304.2.2

Compliance	Description	Data	Compliance	Description	Data
N/A	Ramp Length (in)	64.0	No	Ramp Slope (%)	11.2
No	Ramp Width (in)	46.0	Yes	Ramp XSlope (%)	1.5
N/A	Flare Type LT	N/A	N/A	Flare Type RT	N/A
N/A	Flare Slope LT (%)	N/A	N/A	Flare Slope RT (%)	N/A
N/A	Flare Traversable LT?	N/A	N/A	Flare Traversable RT?	N/A
N/A	Landing Length (in)	N/A	N/A	DWS Provided?	N/A
N/A	Landing Width (in)	N/A	N/A	DWS Contrast?	N/A
N/A	Landing Slope (%)	N/A	N/A	DWS Length (in)	N/A
N/A	Landing X Slope (%)	N/A	N/A	DWS Full Width?	N/A
N/A	Landing Curb? (Y/N)	N/A	N/A	DWS Offset (in)	N/A
N/A	Shared Landing?	N/A			
N/A	Gutter Ponding?	N/A	N/A	Gutter Slope (%)	N/A
N/A	Gutter Lip Ht (in)	N/A	N/A	Gutter X Slope (%)	N/A
N/A	Painted X Walk1?	No	N/A	Painted X Walk2?	N/A
	X Walk 1 Direction	To NW		X Walk 2 Direction	N/A
N/A	X Walk 1 Width (in)	N/A	N/A	X Walk 2 Width (in)	N/A
	X Walk 1 Slope (%)	2.0		X Walk 2 Slope (%)	N/A
	X Walk 1 X Slope (%)	5.0		X Walk 2 X Slope (%)	N/A

N/A	Ramp inside XWalk1?	N/A	N/A	Ramp inside XWalk2?	N/A
	Road Slope (%)	N/A	N/A	Clear Space?	N/A
	Road X Slope (%)	N/A	N/A	Clear Space to XWalk (in)	N/A
N/A	Any Obstructions?	N/A	N/A	Storm Grate/Utility Hazard?	N/A
	Obstruction Type			Storm Grate/Utility Type	
		N/A			N/A
			Yes	Surface Condition? (G/P)	Good

Possible Solutions:

Remove & Replace Entire Ramp.
