## Access Compliance Report Public Rights-of-Way (Curb Ramps)

Intersection ID: 30576 Main Street: HAMILTON\_GREEN\_DR Cross Street: WHITE\_BARN\_CT Location: NE

ADA ID: 08D4D34ADC69 Ramp Type: BlendTrans2 Initial Pass/Fail: Fail Overall Compliance: No Severity Score: 18.75

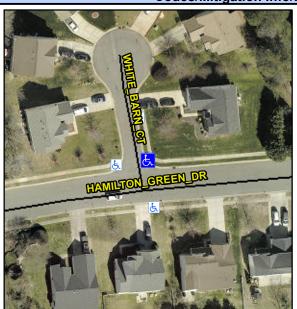
Not Found, R304.5.1, R304.5.3

Comp	liance Description	Data	Comp	liance	Description	Data
N/A	Ramp Length (in)	93.0	Yes	Blend	Trans Slope (%)	3.8
No	Ramp Width (in)	32.0	No	BlendTrans XSlope (%)		2.7
N/A	Flare Type LT	N/A	N/A	Flare	Type RT	N/A
N/A	Flare Slope LT (%)	N/A	N/A	Flare	Slope RT (%)	N/A
N/A	Flare Traversable LT?	N/A	N/A	Flare	Traversable RT?	N/A
N/A	Landing Length (in)	N/A	N/A	DWS	Provided?	N/A
N/A	Landing Width (in)	N/A	N/A	DWS	Contrast?	N/A
N/A	Landing Slope (%)	N/A	N/A	DWS	Length (in)	N/A
N/A	Landing X Slope (%)	N/A	N/A	DWS	Full Width?	N/A
N/A	Landing Curb? (Y/N)	N/A	N/A	DWS	Offset (in)	N/A
N/A	Shared Landing?	N/A				
N/A	Gutter Ponding?	N/A	N/A	Gutte	r Slope (%)	N/A
N/A	Gutter Lip Ht (in)	N/A	N/A	Gutte	r X Slope (%)	N/A
N/A	Painted X Walk1?	No	N/A	Paint	ed X Walk2?	No
	X Walk 1 Direction	To W		X Wa	lk 2 Direction	To S
	X Walk 1 Width (in)	N/A		X Wa	lk 2 Width (in)	N/A
	X Walk 1 Slope (%)	2.2		X Wa	lk 2 Slope (%)	5.4
	X Walk 1 X Slope (%)	0.8		X Wa	lk 2 X Slope (%)	0.1

N/A	Ramp inside XWalk1?	N/A	N/A	Ramp	inside XWalk2?	N/A
	Road Slope (%)	0.2		Clear	Space?	N/A
	Road X Slope (%)	3.2	N/A	Clear	Space to XWalk (in)	N/A
N/A	Any Obstructions?	N/A	N/A	Storm	Grate/Utility Hazard?	N/A
	Obstruction Type			Storm	Grate/Utility Type	
		N/A				N/A
			Yes	Surfa	ce Condition? (G/P)	Good

Remove & Replace Curb Ramp With Two New Directional Ramps or Equivalent.
