Access Compliance Report

Public Rights-of-Way

(Curb Ramps)

Intersection ID: 28715	Main Street: EAGLE_CREEK_DR	Cross Street: DELAMERE_LN	Location: E
ADA ID: 08DC5335CDEB	Ramp Type: PerpDiag	Initial Pass/Fail: Fail	Overall Compliance: No
		Severity Score: 25

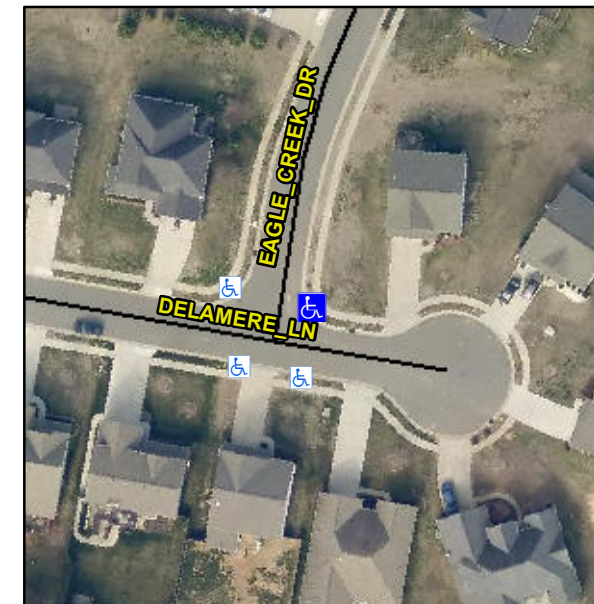
Not Found, R304.5.3

Compliance	Description	Data	Compliance	Description	Data
N/A	Ramp Length (in)	47.0	Yes	Ramp Slope (%)	5.1
Yes	Ramp Width (in)	48.0	No	Ramp XSlope (%)	9.2
N/A	Flare Type LT	N/A	N/A	Flare Type RT	N/A
N/A	Flare Slope LT (%)	N/A	N/A	Flare Slope RT (%)	N/A
N/A	Flare Traversable LT?	N/A	N/A	Flare Traversable RT?	N/A
N/A	Landing Length (in)	N/A	N/A	DWS Provided?	N/A
N/A	Landing Width (in)	N/A	N/A	DWS Contrast?	N/A
N/A	Landing Slope (%)	N/A	N/A	DWS Length (in)	N/A
N/A	Landing X Slope (%)	N/A	N/A	DWS Full Width?	N/A
N/A	Landing Curb? (Y/N)	N/A	N/A	DWS Offset (in)	N/A
N/A	Shared Landing?	N/A			
N/A	Gutter Ponding?	N/A	N/A	Gutter Slope (%)	N/A
N/A	Gutter Lip Ht (in)	N/A	N/A	Gutter X Slope (%)	N/A
N/A	Painted X Walk1?	No	N/A	Painted X Walk2?	No
	X Walk 1 Direction	To NW		X Walk 2 Direction	To SW
N/A	X Walk 1 Width (in)	N/A	N/A	X Walk 2 Width (in)	N/A
	X Walk 1 Slope (%)	2.4		X Walk 2 Slope (%)	4.3
	X Walk 1 X Slope (%)	4.9		X Walk 2 X Slope (%)	4.8

N/A	Ramp inside XWalk1?	N/A	N/A	Ramp inside XWalk2?	N/A
	Road Slope (%)	6.2	N/A	Clear Space?	N/A
	Road X Slope (%)	0.8	N/A	Clear Space to XWalk (in)	N/A
N/A	Any Obstructions?	N/A	N/A	Storm Grate/Utility Hazard?	N/A
	Obstruction Type			Storm Grate/Utility Type	
		N/A			N/A
			Yes	Surface Condition? (G/P)	Good

Remove & Replace Curb Ramp With Two New Directional Ramps or Equivalent.

Total Cost: \$ 3200.00
