Access Compliance Report

Public Rights-of-Way

(Curb Ramps)

Intersection ID: 15763	Main Street: MONROE_RD	Cross Street: N_WENDOVER_RD	Location: S
ADA ID: 08DDF461368C	Ramp Type: PerpDiag	Initial Pass/Fail: Fail	Overall Compliance: No
Codes/Mitigation Info/Possible Solution		Field Measurements/Component Compliance

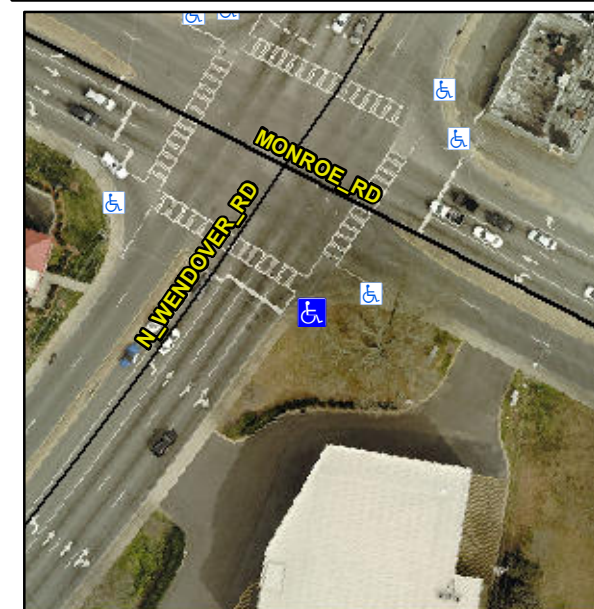
Not Found, R304.5.1, R304.2.2

Compliance	Description	Data	Compliance	Description	Data
N/A	Ramp Length (in)	61.0	No	Ramp Slope (%)	9.4
No	Ramp Width (in)	42.0	Yes	Ramp XSlope (%)	1.3
N/A	Flare Type LT	N/A	N/A	Flare Type RT	N/A
N/A	Flare Slope LT (%)	N/A	N/A	Flare Slope RT (%)	N/A
N/A	Flare Traversable LT?	N/A	N/A	Flare Traversable RT?	N/A
N/A	Landing Length (in)	N/A	N/A	DWS Provided?	N/A
N/A	Landing Width (in)	N/A	N/A	DWS Contrast?	N/A
N/A	Landing Slope (%)	N/A	N/A	DWS Length (in)	N/A
N/A	Landing X Slope (%)	N/A	N/A	DWS Full Width?	N/A
N/A	Landing Curb? (Y/N)	N/A	N/A	DWS Offset (in)	N/A
N/A	Shared Landing?	N/A			
N/A	Gutter Ponding?	N/A	N/A	Gutter Slope (%)	N/A
N/A	Gutter Lip Ht (in)	N/A	N/A	Gutter X Slope (%)	N/A
N/A	Painted X Walk1?	Yes	N/A	Painted X Walk2?	Yes
	X Walk 1 Direction	To NE		X Walk 2 Direction	To NW
N/A	X Walk 1 Width (in)	115.0	N/A	X Walk 2 Width (in)	104.0
	X Walk 1 Slope (%)	1.4		X Walk 2 Slope (%)	1.3
	X Walk 1 X Slope (%)	2.7		X Walk 2 X Slope (%)	2.7

N/A	Ramp inside XWalk1?	Yes	N/A	Ramp inside XWalk2?	No
	Road Slope (%)	0.1	N/A	Clear Space?	N/A
	Road X Slope (%)	2.4	N/A	Clear Space to XWalk (in)	N/A
N/A	Any Obstructions?	N/A	N/A	Storm Grate/Utility Hazard?	N/A
	Obstruction Type			Storm Grate/Utility Type	
		N/A			N/A
			Yes	Surface Condition? (G/P)	Good

Possible Solutions:

Remove & Replace Curb Ramp With Two New Directional Ramps or Equivalent. Restripe Crosswalk.
