# Access Compliance Report

## Public Rights-of-Way

### (Curb Ramps)

Intersection ID: 8943	Main Street: FREEDOM_DR	Cross Street: WESTSTONE_DR	Location: NW
ADA ID: 08E0D41E2AFA	Ramp Type: Perp	Initial Pass/Fail: Fail	Overall Compliance: No
			Severity Score: 21.25

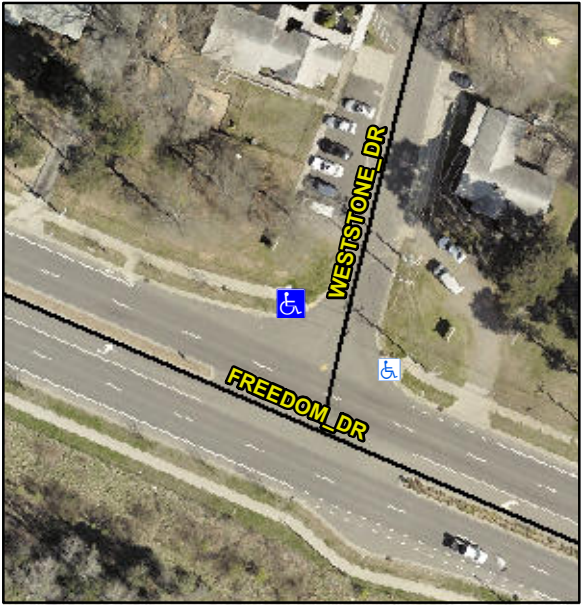
Possible Solutions:		<b>Compliance</b>	<b>Description</b>	<b>Data</b>
	<b>Remove &amp; Replace Entire Ramp.</b>		<b>Yes</b>	Ramp Length (in)	85.0
			<b>No</b>	Ramp Width (in)	46.5
			<b>N/A</b>	Flare Type LT	N/A
			<b>N/A</b>	Flare Slope LT (%)	N/A
			<b>N/A</b>	Flare Traversable LT?	N/A
			<b>N/A</b>	Landing Length (in)	N/A
			<b>N/A</b>	Landing Width (in)	N/A
			<b>N/A</b>	Landing Slope (%)	N/A
			<b>N/A</b>	Landing X Slope (%)	N/A
<p>Surveyor Notes:</p> <p><b>N/A</b></p> <p>PROW/ADA:</p> <p><b>Not Found, R304.5.1, R304.5.3</b></p>			<b>N/A</b>	Flare Type RT	N/A
			<b>N/A</b>	Flare Slope RT (%)	N/A
			<b>N/A</b>	Flare Traversable RT?	N/A
			<b>N/A</b>	DWS Provided?	N/A
			<b>N/A</b>	DWS Contrast?	N/A
			<b>N/A</b>	DWS Length (in)	N/A
			<b>N/A</b>	DWS Full Width?	N/A
			<b>N/A</b>	DWS Offset (in)	N/A
			<b>N/A</b>	Gutter Ponding?	N/A

<b>N/A</b>	Gutter Lip Ht (in)	N/A
			<b>No</b>	Painted X Walk1?	N/A
				X Walk 1 Direction	To SE
			<b>N/A</b>	X Walk 1 Width (in)	N/A
				X Walk 1 Slope (%)	3.5
				X Walk 1 X Slope (%)	5.1
			<b>N/A</b>	Ramp inside XWalk1?	N/A
			<b>N/A</b>	Road Slope (%)	N/A
			<b>N/A</b>	Road X Slope (%)	N/A
			<b>N/A</b>	Any Obstructions?	N/A
				Obstruction Type	
Total Cost:		\$ 1850.00	<b>N/A</b>	Storm Grate/Utility Hazard?	N/A
			<b>N/A</b>	Storm Grate/Utility Type	N/A
			<b>Yes</b>	Surface Condition? (G/P)	Good
