Access Compliance Report Public Rights-of-Way (Curb Ramps)

Intersection ID: 43733 Main Street: GLORY_ST Cross Street: TIFFANY_ROSE_PL Location: SE

ADA ID: 08E509D0329C Ramp Type: Para Initial Pass/Fail: Fail Overall Compliance: No Severity Score: 21.25

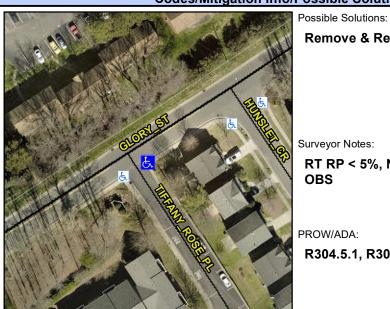
RT RP < 5%, NO RT SW, OVHD VEG OBS

Compliance Description Data Compliance Description Data					
N/A	Ramp Length LT (in)	29.0	N/A	Ramp Length RT (in)	42.5
No	Ramp Width LT (in)	47.5	No	Ramp Width RT (in)	47.5
No	Ramp Slope LT (%)	10.7	Yes	Ramp Slope RT (%)	4.3
Yes	Ramp XSlope LT (%)	0.5	Yes	Ramp XSlope RT (%)	0.5
N/A	Landing Length (in)	N/A	N/A	DWS Provided?	N/A
N/A N/A	0 0 ()	N/A N/A	N/A N/A	DWS Contrast?	N/A N/A
	Landing Width (in)				N/A
N/A	Landing Slope (%)	N/A	N/A	DWS Length (in)	
N/A	Landing X Slope (%)	N/A	N/A	DWS Full Width?	N/A
N/A	Landing Curb? (Y/N)	N/A	N/A	DWS Offset (in)	N/A
N/A	Shared Landing?	N/A	l		
N/A	Gutter Ponding?	N/A	N/A	Gutter Slope (%)	N/A
N/A	Gutter Lip Ht (in)	1.0	N/A	Gutter X Slope (%)	N/A
N/A	Painted X Walk1?	No	N/A	Painted X Walk2?	N/A
	X Walk 1 Direction	To SW		X Walk 2 Direction	N/A
N/A	X Walk 1 Width (in)	N/A	N/A	X Walk 2 Width (in)	N/A
	X Walk 1 Slope (%)	0.5		X Walk 2 Slope (%)	N/A
	X Walk 1 X Slope (%)	3.2		X Walk 2 X Slope (%)	N/A

N/A	Ramp inside XWalk1?	N/A	N/A	Ramp inside XWalk2?	N/A
	Road Slope (%)	N/A	N/A	Clear Space?	N/A
	Road X Slope (%)	N/A	N/A	Clear Space to XWalk (in)	N/A
N/A	Any Obstructions?	N/A	N/A	Storm Grate/Utility Hazard?	N/A
	Obstruction Type			Storm Grate/Utility Type	
		N/A			N/A
			Yes	Surface Condition? (G/P)	Good
			N/A	Curb Slope (%)	19.4
4		·	-

PROW/ADA:
R304.5.1, R304.3.2

Total Cost: \$ 1600.00
