## Access Compliance Report Public Rights-of-Way (Curb Ramps)

Intersection ID: 13197 Main Street: S\_MCDOWELL\_ST Cross Street: E\_4TH\_ST Location: S

ADA ID: 08EF2C0E0738 Ramp Type: Perp Initial Pass/Fail: Fail Overall Compliance: No Severity Score: 37.5

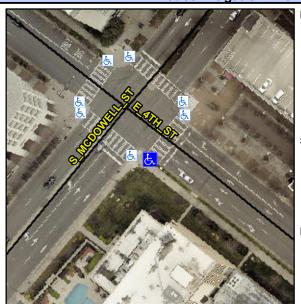
Field Measurements/Component Compnance							
Compliance Description Data			Comp	oliance Description	Data		
N/A	Ramp Length (in)	60.0	No	Ramp Slope (%)	9.0		
Yes	Ramp Width (in)	49.0	No	Ramp XSlope (%)	10.6		
N/A	Flare Type LT	N/A	N/A	Flare Type RT	N/A		
N/A	Flare Slope LT (%)	N/A	N/A	Flare Slope RT (%)	N/A		
N/A	Flare Traversable LT?	N/A	N/A	Flare Traversable RT?	N/A		
N/A	Landing Length (in)	N/A	N/A	DWS Provided?	N/A		
N/A	Landing Width (in)	N/A	N/A	DWS Contrast?	N/A		
N/A	Landing Slope (%)	N/A	N/A	DWS Length (in)	N/A		
N/A	Landing X Slope (%)	N/A	N/A	DWS Full Width?	N/A		
N/A	Landing Curb? (Y/N)	N/A	N/A	DWS Offset (in)	N/A		
N/A	Shared Landing?	N/A					
N/A	Gutter Ponding?	N/A	N/A	Gutter Slope (%)	N/A		
N/A	Gutter Lip Ht (in)	N/A	N/A	Gutter X Slope (%)	N/A		
N/A	Painted X Walk1?	Yes	N/A	Painted X Walk2?	N/A		
	X Walk 1 Direction	To NE		X Walk 2 Direction	N/A		
N/A	X Walk 1 Width (in)	181.0	N/A	X Walk 2 Width (in)	N/A

X Walk 1 Slope (%)	4.5		X Walk 2 Slope (%)	N/A		
	X Walk 1 X Slope (%)	1.1		X Walk 2 X Slope (%)	N/A		
N/A	Ramp inside XWalk1?	Yes	N/A	Ramp inside XWalk2?	N/A		
	Road Slope (%)	N/A	N/A	Clear Space?	N/A		
	Road X Slope (%)	N/A	N/A	Clear Space to XWalk (in)	N/A		
N/A	Any Obstructions?	N/A	N/A	Storm Grate/Utility Hazard?	N/A		
	Obstruction Type		Į.	Storm Grate/Utility Type			
		N/A			N/A		
			Yes	Surface Condition? (G/P)	Good

Remove & Replace Entire Ramp.

R304.2.2, R304.5.3
