Access Compliance Report

Public Rights-of-Way

(Curb Ramps)

Intersection ID: 2501	Main Street: BENTGRASS_RUN_DR	Cross Street: WHISTLER'S_CHASE_DR	Location: E
ADA ID: 08F314E32747	Ramp Type: PerpDiag	Initial Pass/Fail: Fail	Overall Compliance: No
Codes/Mitigation Info/Possible Solution		Field Measurements/Component Compliance	
Severity Score: 13.75

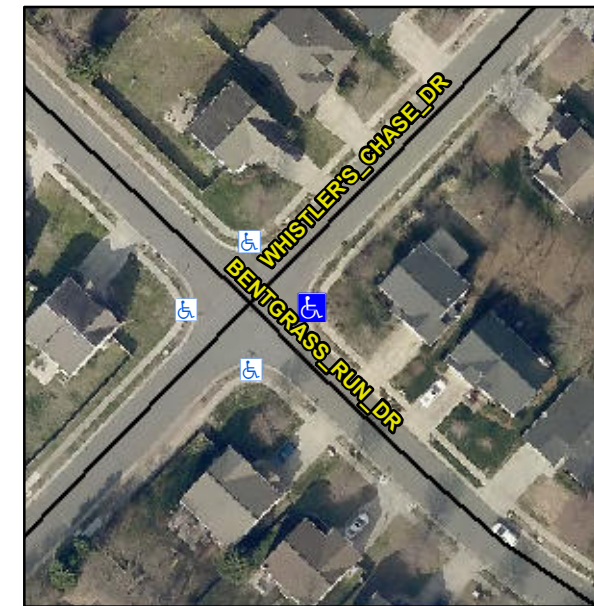
Not Found, R304.2.2, R304.5.3

Compliance	Description	Data	Compliance	Description	Data
N/A	Ramp Length (in)	49.0	No	Ramp Slope (%)	9.6
Yes	Ramp Width (in)	60.0	No	Ramp XSlope (%)	2.2
N/A	Flare Type LT	N/A	N/A	Flare Type RT	N/A
N/A	Flare Slope LT (%)	N/A	N/A	Flare Slope RT (%)	N/A
N/A	Flare Traversable LT?	N/A	N/A	Flare Traversable RT?	N/A
N/A	Landing Length (in)	N/A	N/A	DWS Provided?	N/A
N/A	Landing Width (in)	N/A	N/A	DWS Contrast?	N/A
N/A	Landing Slope (%)	N/A	N/A	DWS Length (in)	N/A
N/A	Landing X Slope (%)	N/A	N/A	DWS Full Width?	N/A
N/A	Landing Curb? (Y/N)	N/A	N/A	DWS Offset (in)	N/A
N/A	Shared Landing?	N/A			
N/A	Gutter Ponding?	N/A	N/A	Gutter Slope (%)	N/A
N/A	Gutter Lip Ht (in)	N/A	N/A	Gutter X Slope (%)	N/A
N/A	Painted X Walk1?	No	N/A	Painted X Walk2?	No
	X Walk 1 Direction	To NW		X Walk 2 Direction	To SW
N/A	X Walk 1 Width (in)	N/A	N/A	X Walk 2 Width (in)	N/A
	X Walk 1 Slope (%)	7.0		X Walk 2 Slope (%)	3.7
	X Walk 1 X Slope (%)	0.4		X Walk 2 X Slope (%)	5.2

N/A	Ramp inside XWalk1?	N/A	N/A	Ramp inside XWalk2?	N/A
	Road Slope (%)	2.0	N/A	Clear Space?	N/A
	Road X Slope (%)	7.6	N/A	Clear Space to XWalk (in)	N/A
N/A	Any Obstructions?	N/A	N/A	Storm Grate/Utility Hazard?	N/A
	Obstruction Type			Storm Grate/Utility Type	
		N/A			N/A
			Yes	Surface Condition? (G/P)	Good

Remove & Replace Curb Ramp With Two New Directional Ramps or Equivalent.
