Access Compliance Report

Public Rights-of-Way

(Curb Ramps)

Intersection ID: 26038	Main Street: ELM_LN	Cross Street: PINEVILLE-MATTHEWS_RD	Location: N
ADA ID: 0900A981164F	Ramp Type: Perp	Initial Pass/Fail: Fail	Overall Compliance: No
Severity Score: 18.75			
Codes/Mitigation Info/Possible Solution		Field Measurements/Component Compliance

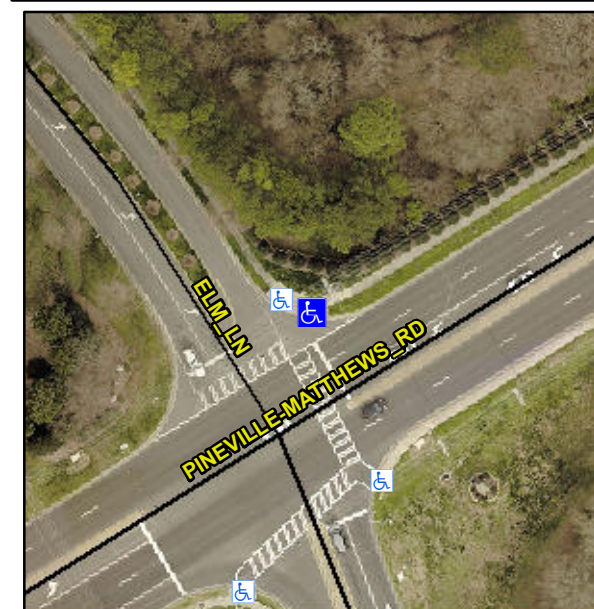
Not Found, R304.5.1, R304.5.3

Compliance	Description	Data	Compliance	Description	Data
N/A	Ramp Length (in)	105.0	Yes	Ramp Slope (%)	6.8
No	Ramp Width (in)	35.0	No	Ramp XSlope (%)	3.1
N/A	Flare Type LT	N/A	N/A	Flare Type RT	N/A
N/A	Flare Slope LT (%)	N/A	N/A	Flare Slope RT (%)	N/A
N/A	Flare Traversable LT?	N/A	N/A	Flare Traversable RT?	N/A
N/A	Landing Length (in)	N/A	N/A	DWS Provided?	N/A
N/A	Landing Width (in)	N/A	N/A	DWS Contrast?	N/A
N/A	Landing Slope (%)	N/A	N/A	DWS Length (in)	N/A
N/A	Landing X Slope (%)	N/A	N/A	DWS Full Width?	N/A
N/A	Landing Curb? (Y/N)	N/A	N/A	DWS Offset (in)	N/A
N/A	Shared Landing?	N/A			
N/A	Gutter Ponding?	N/A	N/A	Gutter Slope (%)	N/A
N/A	Gutter Lip Ht (in)	N/A	N/A	Gutter X Slope (%)	N/A
N/A	Painted X Walk1?	No	N/A	Painted X Walk2?	N/A
	X Walk 1 Direction	To SE		X Walk 2 Direction	N/A
N/A	X Walk 1 Width (in)	N/A	N/A	X Walk 2 Width (in)	N/A
	X Walk 1 Slope (%)	0.9		X Walk 2 Slope (%)	N/A
	X Walk 1 X Slope (%)	0.2		X Walk 2 X Slope (%)	N/A

N/A	Ramp inside XWalk1?	N/A	N/A	Ramp inside XWalk2?	N/A
	Road Slope (%)	N/A	N/A	Clear Space?	N/A
	Road X Slope (%)	N/A	N/A	Clear Space to XWalk (in)	N/A
N/A	Any Obstructions?	N/A	N/A	Storm Grate/Utility Hazard?	N/A
	Obstruction Type			Storm Grate/Utility Type	
		N/A			N/A
			Yes	Surface Condition? (G/P)	Good

Possible Solutions:

Remove & Replace Entire Ramp.

Total Cost: \$ 1850.00
