# Access Compliance Report

## Public Rights-of-Way (Curb Ramps)

| Intersection ID: 10034403 | Main Street: PIEDMONT_ROW_DR_SOUTH | Cross Street: N/A | Location: SE |
| ADA ID: 0906101DAFFA | Ramp Type: PerpDiag | Initial Pass/Fail: Fail | Overall Compliance: No |

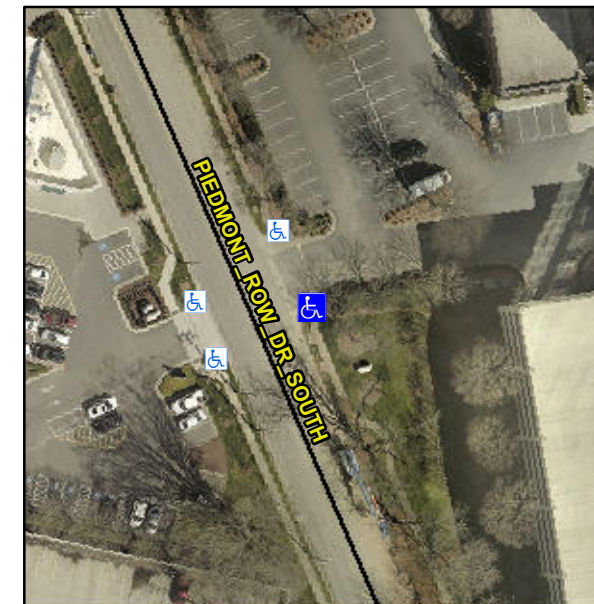
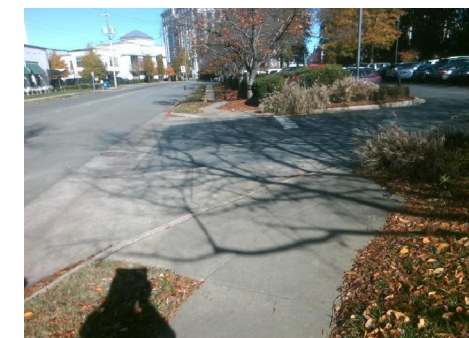
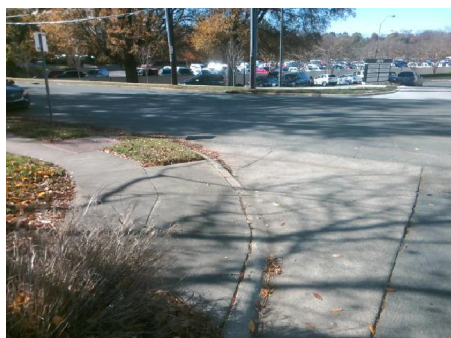
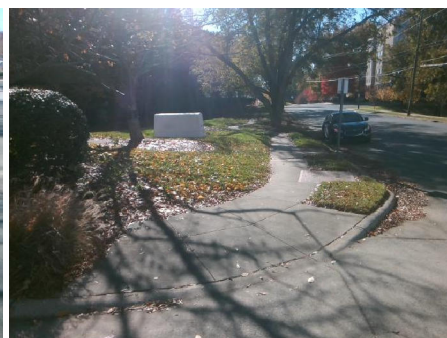
**Not Found, R304.5.1, R304.2.2, R304.5.3**

| Compliance | Description | Data | Compliance | Description | Data |
|---|---|---|---|---|---|
| N/A | Ramp Length (in) | 47.0 | No | Ramp Slope (%) | 8.6 |
| No | Ramp Width (in) | 45.0 | No | Ramp XSlope (%) | 5.6 |

**Remove & Replace Curb Ramp With Two New Directional Ramps or Equivalent.**
