# Access Compliance Report

## Public Rights-of-Way

### (Curb Ramps)

| Intersection ID: 14648 | Main Street: EAST_BV | Cross Street: LENNOX_AV | Location: S |

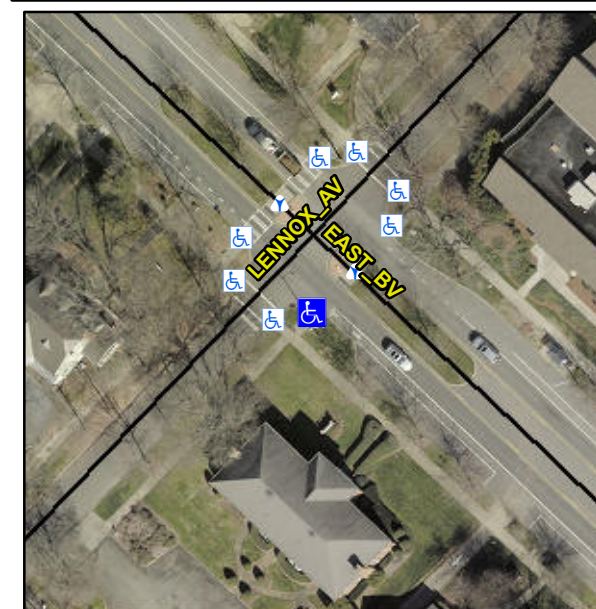
| ADA ID: 090D86F521A6 | Ramp Type: Directional1 | Initial Pass/Fail: Fail | Overall Compliance: No |
| Severity Score: 12.5 | | | |

**R304.2.2**

| Compliance | Description | Data | Compliance | Description | Data |
|---|---|---|---|---|---|
| No | Ramp Slope (%) | 9.2 | N/A | Grade Break XSlope (%) | 0.0 |

**Remove & Replace Entire Ramp.**

Total Cost: \$ 1600.00
