## **Access Compliance Report Public Rights-of-Way** (Curb Ramps)

Intersection ID: 49136 Main Street: AMBER LEIGH WAY DR Cross Street: POPE FARM RD Location: Ν **Overall Compliance: No** ADA ID: 09161D2C9B3D Ramp Type: Perp Initial Pass/Fail: Fail Severity Score: 33.75

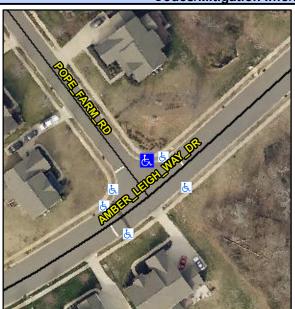
Compliance Description Data Compliance Description Data Yes N/A Ramp Length (in) 45.0 Ramp Slope (%) 5.6 No No Ramp Width (in) 47.5 Ramp XSlope (%) 7.0 N/A Flare Type LT N/A N/A Flare Type RT N/A N/A N/A N/A Flare Slope RT (%) Flare Slope LT (%) N/A N/A Flare Traversable LT? N/A N/A Flare Traversable RT? N/A N/A N/A N/A **DWS Provided?** N/A Landing Length (in) N/A Landing Width (in) N/A N/A **DWS Contrast?** N/A N/A N/A Landing Slope (%) N/A DWS Length (in) N/A N/A Landing X Slope (%) N/A N/A DWS Full Width? N/A N/A Landing Curb? (Y/N) N/A N/A DWS Offset (in) N/A N/A N/A Shared Landing? N/A **Gutter Ponding?** N/A N/A Gutter Slope (%) N/A Gutter Lip Ht (in) N/A N/A Gutter X Slope (%) N/A Painted X Walk1? No N/A Painted X Walk2? N/A X Walk 1 Direction To SW X Walk 2 Direction N/A N/A X Walk 1 Width (in) X Walk 2 Width (in) N/A X Walk 1 Slope (%) 4.6 X Walk 2 Slope (%) N/A X Walk 1 X Slope (%) 4.7 X Walk 2 X Slope (%) N/A N/A Ramp inside XWalk1? N/A Ramp inside XWalk2? N/A Road Slope (%) N/A N/A Clear Space? N/A Road X Slope (%) N/A N/A Clear Space to XWalk (in) N/A N/A Any Obstructions? N/A Storm Grate/Utility Hazard? N/A **Obstruction Type** Storm Grate/Utility Type N/A N/A Yes Surface Condition? (G/P) Good

POPE FARM RD Street 1 Name Stop Condition-Street 2 StopSign N/A Street 2 Name Stop Condition-Street 1 N/A Possible Solutions: Remove & Replace Entire Ramp. Surveyor Notes: N/A PROW/ADA: Not Found, R304.5.1, R304.5.3
