Access Compliance Report

Public Rights-of-Way

(Curb Ramps)

Intersection ID: N/A	Main Street: SOUTH_BV	Cross Street: N/A	Location: S
ADA ID: 0916F35BCCC9	Ramp Type: Directional1	Initial Pass/Fail: Fail	Overall Compliance: No
		Severity Score: 1.25

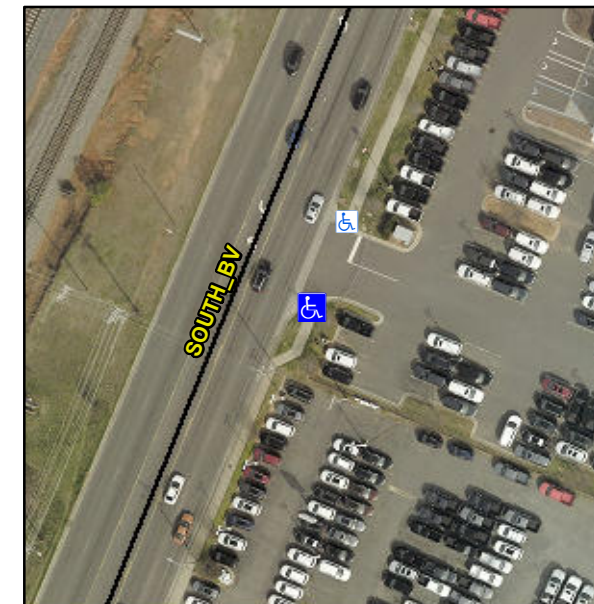
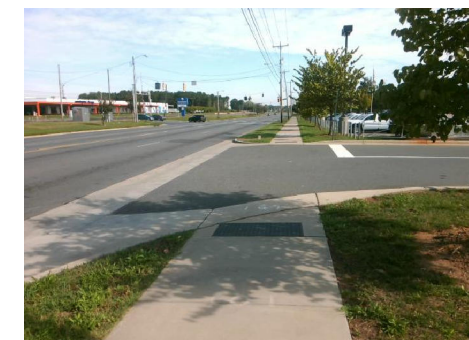
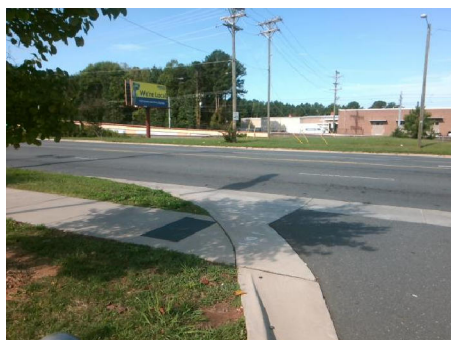
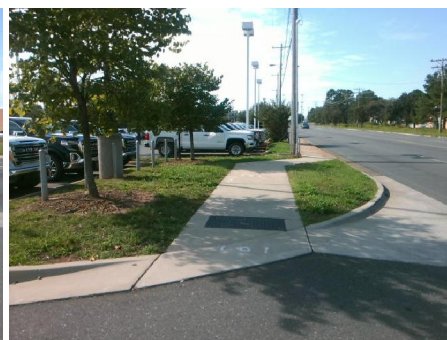
R304.5.3

Compliance	Description	Data	Compliance	Description	Data
N/A	Ramp Length (in)	59.0	N/A	Grade Break?	N/A
Yes	Ramp Width (in)	48.0	N/A	Grade Break Slope (%)	0.0
Yes	Ramp Slope (%)	3.4	N/A	Grade Break XSlope (%)	0.0
No	Ramp XSlope (%)	2.6			
N/A	Flare Type LT	N/A	N/A	Flare Type RT	N/A
N/A	Flare Slope LT (%)	N/A	N/A	Flare Slope RT (%)	0.0
N/A	Flare Traversable LT?	N/A	N/A	Flare Traversable RT?	N/A
N/A	Landing Length (in)	0.0	N/A	DWS Provided?	N/A
N/A	Landing Width (in)	0.0	N/A	DWS Contrast?	N/A
N/A	Landing Slope (%)	0.0	N/A	DWS Length (in)	N/A
N/A	Landing X Slope (%)	0.0	N/A	DWS Full Width?	N/A
N/A	Landing Curb? (Y/N)	N/A	N/A	DWS Offset LT (in)	N/A
N/A	Shared Landing?	N/A	N/A	DWS Offset RT (in)	N/A
N/A	Gutter Ponding?	0.0	N/A	Gutter Slope (%)	N/A
N/A	Gutter Lip Ht (in)	0.0	N/A	Gutter X Slope (%)	N/A
N/A	Painted X Walk1?	No		Road Slope (%)	4.3
	X Walk 1 Direction	To N		Road X Slope (%)	0.7
	X Walk 1 Width (in)	N/A		Clear Space?	N/A

X Walk 1 Slope (%)	4.3	N/A	Clear Space to XWalk (in)	N/A
	X Walk 1 X Slope (%)	0.7	N/A	Storm Grate/Utility Hazard?	N/A
N/A	Ramp inside XWalk1?	N/A		Storm Grate/Utility Type	
N/A	Any Obstructions?	N/A			N/A
	Obstruction Type		Yes	Surface Condition? (G/P)	Good
			N/A	Curb Slope (%)	1.2

Remove & Replace Entire Ramp.
