Access Compliance Report

Public Rights-of-Way

(Curb Ramps)

Intersection ID: 10034592	Main Street: PIPER_STATION_DR	Cross Street: N/A	Location: E
ADA ID: 0919FF032C53	Ramp Type: BlendTrans2	Initial Pass/Fail: Fail	Overall Compliance: No
Severity Score: 25			
Codes/Mitigation Info/Possible Solution		Field Measurements/Component Compliance

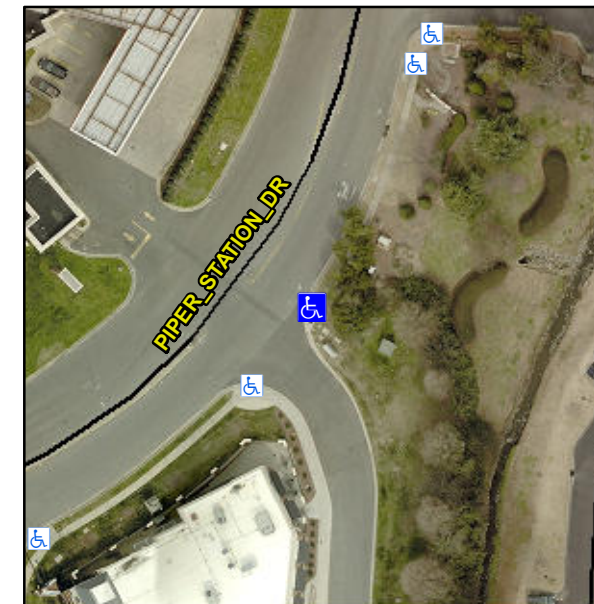
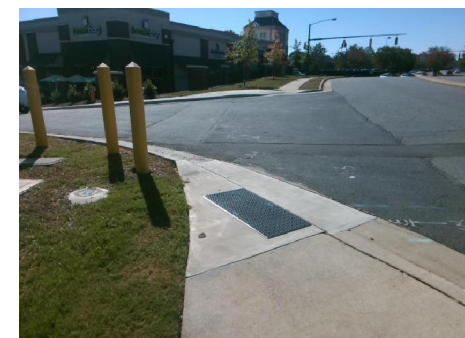
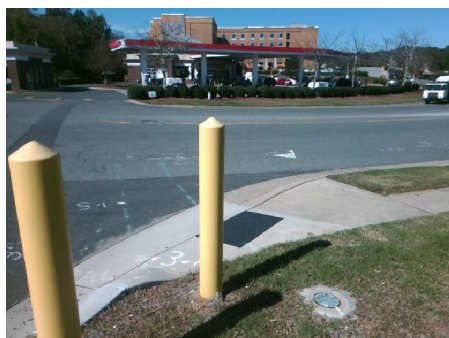
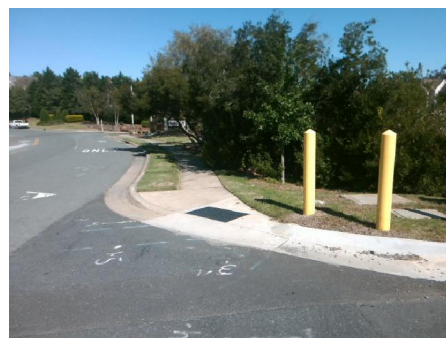
R304.5.3

Compliance	Description	Data	Compliance	Description	Data
N/A	Ramp Length (in)	43.0	Yes	BlendTrans Slope (%)	1.9
Yes	Ramp Width (in)	48.0	No	BlendTrans XSlope (%)	7.4
N/A	Flare Type LT	N/A	N/A	Flare Type RT	N/A
N/A	Flare Slope LT (%)	N/A	N/A	Flare Slope RT (%)	N/A
N/A	Flare Traversable LT?	N/A	N/A	Flare Traversable RT?	N/A
N/A	Landing Length (in)	N/A	N/A	DWS Provided?	N/A
N/A	Landing Width (in)	N/A	N/A	DWS Contrast?	N/A
N/A	Landing Slope (%)	N/A	N/A	DWS Length (in)	N/A
N/A	Landing X Slope (%)	N/A	N/A	DWS Full Width?	N/A
N/A	Landing Curb? (Y/N)	N/A	N/A	DWS Offset (in)	N/A
N/A	Shared Landing?	N/A			
N/A	Gutter Ponding?	N/A	N/A	Gutter Slope (%)	N/A
N/A	Gutter Lip Ht (in)	N/A	N/A	Gutter X Slope (%)	N/A
N/A	Painted X Walk1?	No	N/A	Painted X Walk2?	No
	X Walk 1 Direction	To NW		X Walk 2 Direction	To SW
	X Walk 1 Width (in)	N/A		X Walk 2 Width (in)	N/A
	X Walk 1 Slope (%)	3.6		X Walk 2 Slope (%)	5.4
	X Walk 1 X Slope (%)	4.9		X Walk 2 X Slope (%)	0.3

N/A	Ramp inside XWalk1?	N/A	N/A	Ramp inside XWalk2?	N/A
	Road Slope (%)	4.8		Clear Space?	N/A
	Road X Slope (%)	2.1	N/A	Clear Space to XWalk (in)	N/A
N/A	Any Obstructions?	N/A	N/A	Storm Grate/Utility Hazard?	N/A
	Obstruction Type			Storm Grate/Utility Type	
		N/A			N/A
			Yes	Surface Condition? (G/P)	Good
			N/A	Curb Slope (%)	3.1

Possible Solutions:

Remove & Replace Curb Ramp With Two New Directional Ramps or Equivalent.

Total Cost: \$ 3200.00
