Access Compliance Report

Public Rights-of-Way

(Curb Ramps)

Intersection ID: N/A	Main Street: PERIMETER_PY	Cross Street: N/A	Location: NE
ADA ID: 0923B1533832	Ramp Type: PerpDiag	Initial Pass/Fail: Fail	Overall Compliance: No
		Severity Score: 12.5

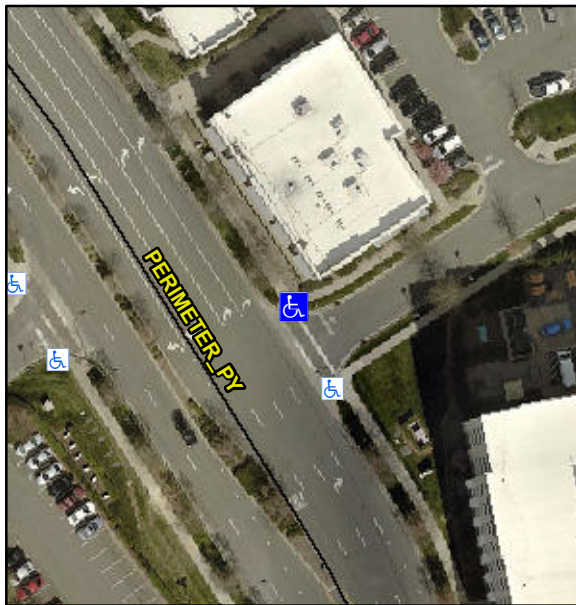
Compliance	Description	Data	Compliance	Description	Data
N/A	Ramp Length (in)	75.0	Yes	Ramp Slope (%)	6.7
Yes	Ramp Width (in)	48.0	No	Ramp XSlope (%)	5.8
N/A	Flare Type LT	N/A	N/A	Flare Type RT	N/A
N/A	Flare Slope LT (%)	N/A	N/A	Flare Slope RT (%)	N/A
N/A	Flare Traversable LT?	No	N/A	Flare Traversable RT?	No
N/A	Landing Length (in)	N/A	N/A	DWS Provided?	N/A
N/A	Landing Width (in)	N/A	N/A	DWS Contrast?	N/A
N/A	Landing Slope (%)	N/A	N/A	DWS Length (in)	N/A
N/A	Landing X Slope (%)	N/A	N/A	DWS Full Width?	N/A
N/A	Landing Curb? (Y/N)	N/A	N/A	DWS Offset (in)	N/A
N/A	Shared Landing?	N/A			
N/A	Gutter Ponding?	N/A	N/A	Gutter Slope (%)	N/A
N/A	Gutter Lip Ht (in)	N/A	N/A	Gutter X Slope (%)	N/A
N/A	Painted X Walk1?	No	N/A	Painted X Walk2?	Yes
	X Walk 1 Direction	To W		X Walk 2 Direction	To S
N/A	X Walk 1 Width (in)	N/A	N/A	X Walk 2 Width (in)	70.5
	X Walk 1 Slope (%)	0.1		X Walk 2 Slope (%)	1.0
	X Walk 1 X Slope (%)	0.9		X Walk 2 X Slope (%)	0.3

N/A	Ramp inside XWalk1?	N/A	N/A	Ramp inside XWalk2?	Yes
	Road Slope (%)	2.7	N/A	Clear Space?	N/A
	Road X Slope (%)	0.7	N/A	Clear Space to XWalk (in)	N/A
N/A	Any Obstructions?	N/A	N/A	Storm Grate/Utility Hazard?	N/A
	Obstruction Type			Storm Grate/Utility Type	
		N/A			N/A
			Yes	Surface Condition? (G/P)	Good

Remove & Replace Curb Ramp With Two New Directional Ramps or Equivalent.
