Access Compliance Report

Public Rights-of-Way

(Curb Ramps)

Intersection ID: 14763	Main Street: HERMITAGE_RD	Cross Street: QUEENS_RD	Location: SW
ADA ID: 09267C6CE2CF	Ramp Type: Perp	Initial Pass/Fail: Fail	Overall Compliance: No
		Severity Score: 22.5

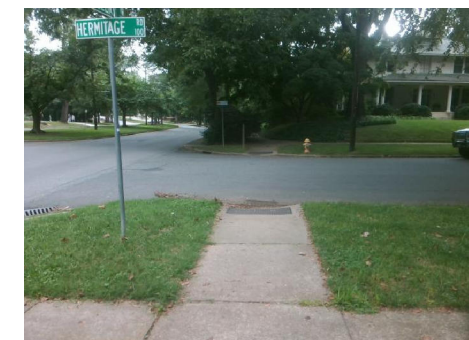
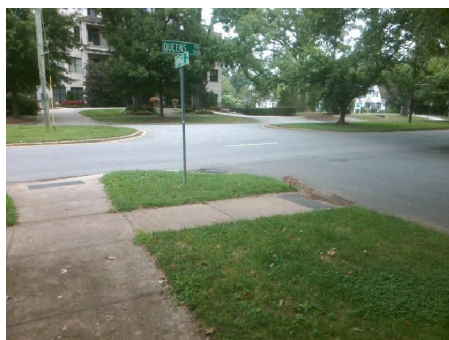
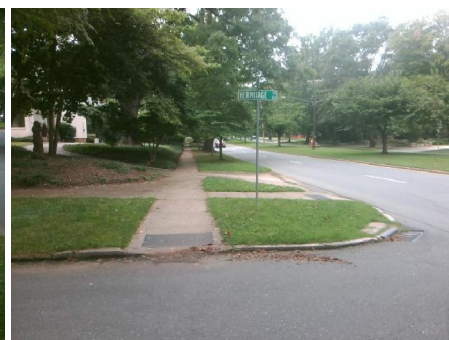
Not Found, R304.5.1, R304.2.2, R304.5.3

Compliance	Description	Data	Compliance	Description	Data
N/A	Ramp Length (in)	46.0	No	Ramp Slope (%)	9.0
No	Ramp Width (in)	37.0	No	Ramp XSlope (%)	4.3
N/A	Flare Type LT	N/A	N/A	Flare Type RT	N/A
N/A	Flare Slope LT (%)	N/A	N/A	Flare Slope RT (%)	N/A
N/A	Flare Traversable LT?	N/A	N/A	Flare Traversable RT?	N/A
N/A	Landing Length (in)	N/A	N/A	DWS Provided?	N/A
N/A	Landing Width (in)	N/A	N/A	DWS Contrast?	N/A
N/A	Landing Slope (%)	N/A	N/A	DWS Length (in)	N/A
N/A	Landing X Slope (%)	N/A	N/A	DWS Full Width?	N/A
N/A	Landing Curb? (Y/N)	N/A	N/A	DWS Offset (in)	N/A
N/A	Shared Landing?	N/A			
N/A	Gutter Ponding?	Yes	N/A	Gutter Slope (%)	N/A
N/A	Gutter Lip Ht (in)	N/A	N/A	Gutter X Slope (%)	N/A
N/A	Painted X Walk1?	No	N/A	Painted X Walk2?	N/A
	X Walk 1 Direction	To NE		X Walk 2 Direction	N/A
N/A	X Walk 1 Width (in)	N/A	N/A	X Walk 2 Width (in)	N/A
	X Walk 1 Slope (%)	5.9		X Walk 2 Slope (%)	N/A
	X Walk 1 X Slope (%)	1.9		X Walk 2 X Slope (%)	N/A

Remove & Replace Entire Ramp.

Total Cost: \$ 1850.00
