# Access Compliance Report

## Public Rights-of-Way (Curb Ramps)

Intersection ID: 9996	Main Street: BARRINGTON_DR	Cross Street: WOODY_GLEN_PL	Location: SW
ADA ID: 09321E110C44	Ramp Type: Directional1	Initial Pass/Fail: Pass	Overall Compliance: No
		Severity Score: 25

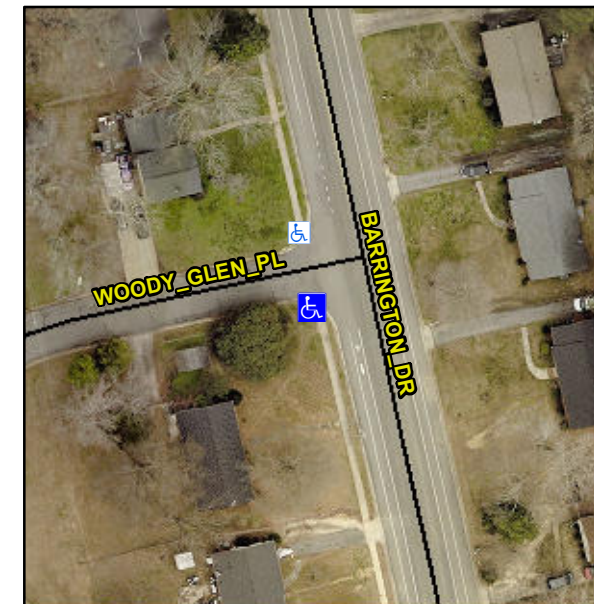
Compliance	Description	Data	Compliance	Description	Data
N/A	Ramp Length (in)	100.0	No	Grade Break?	No
Yes	Ramp Width (in)	60.5	N/A	Grade Break Slope (%)	N/A
Yes	Ramp Slope (%)	5.4	N/A	Grade Break XSlope (%)	N/A
Yes	Ramp XSlope (%)	0.9			
N/A	Flare Type LT	N/A	N/A	Flare Type RT	N/A
Yes	Flare Slope LT (%)	2.7	N/A	Flare Slope RT (%)	3.5
N/A	Flare Traversable LT?	Yes	N/A	Flare Traversable RT?	No
Yes	Landing Length (in)	50.5	No	DWS Provided?	No
Yes	Landing Width (in)	53.0	N/A	DWS Contrast?	No
No	Landing Slope (%)	2.9	N/A	DWS Length (in)	N/A
Yes	Landing X Slope (%)	0.7	N/A	DWS Full Width?	No
N/A	Landing Curb? (Y/N)	N/A	N/A	DWS Offset LT (in)	N/A
N/A	Shared Landing?	No	N/A	DWS Offset RT (in)	N/A
Yes	Gutter Ponding?	No	Yes	Gutter Slope (%)	4.9
No	Gutter Lip Ht (in)	1.0	Yes	Gutter X Slope (%)	0.1
N/A	Painted X Walk1?	No		Road Slope (%)	4.1
	X Walk 1 Direction	To NW		Road X Slope (%)	5.6
	X Walk 1 Width (in)	N/A		Clear Space?	Yes

X Walk 1 Slope (%)	4.1	N/A	Clear Space to XWalk (in)	N/A
	X Walk 1 X Slope (%)	5.6	Yes	Storm Grate/Utility Hazard?	No
N/A	Ramp inside XWalk1?	N/A		Storm Grate/Utility Type	
Yes	Any Obstructions?	No			N/A
	Obstruction Type		Yes	Surface Condition? (G/P)	Good
			N/A	Curb Slope (%)	10.9

**Remove & Replace Entire Ramp.**
