Access Compliance Report

Public Rights-of-Way

(Curb Ramps)

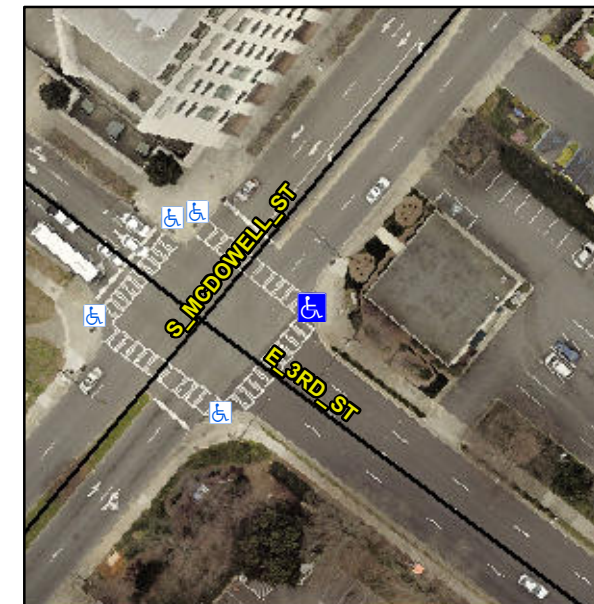
Intersection ID: 13292	Main Street: E_3RD_ST	Cross Street: S_MCDOWELL_ST	Location: E
ADA ID: 09389A2EE550	Ramp Type: PerpDiag	Initial Pass/Fail: Fail	Overall Compliance: No
Severity Score: 10			
Codes/Mitigation Info/Possible Solution		Field Measurements/Component Compliance

Compliance	Description	Data	Compliance	Description	Data
N/A	Ramp Length (in)	104.0	Yes	Ramp Slope (%)	5.2
No	Ramp Width (in)	38.0	Yes	Ramp XSlope (%)	2.4
N/A	Flare Type LT	N/A	N/A	Flare Type RT	N/A
N/A	Flare Slope LT (%)	N/A	N/A	Flare Slope RT (%)	N/A
N/A	Flare Traversable LT?	N/A	N/A	Flare Traversable RT?	N/A
N/A	Landing Length (in)	N/A	N/A	DWS Provided?	N/A
N/A	Landing Width (in)	N/A	N/A	DWS Contrast?	N/A
N/A	Landing Slope (%)	N/A	N/A	DWS Length (in)	N/A
N/A	Landing X Slope (%)	N/A	N/A	DWS Full Width?	N/A
N/A	Landing Curb? (Y/N)	N/A	N/A	DWS Offset (in)	N/A
N/A	Shared Landing?	N/A			
N/A	Gutter Ponding?	N/A	N/A	Gutter Slope (%)	N/A
N/A	Gutter Lip Ht (in)	N/A	N/A	Gutter X Slope (%)	N/A
N/A	Painted X Walk1?	Yes	N/A	Painted X Walk2?	Yes
	X Walk 1 Direction	To NW		X Walk 2 Direction	To SW
N/A	X Walk 1 Width (in)	118.0	N/A	X Walk 2 Width (in)	112.0
	X Walk 1 Slope (%)	4.1		X Walk 2 Slope (%)	0.1
	X Walk 1 X Slope (%)	0.2		X Walk 2 X Slope (%)	2.9

N/A	Ramp inside XWalk1?	Yes	N/A	Ramp inside XWalk2?	Yes
	Road Slope (%)	2.4	N/A	Clear Space?	N/A
	Road X Slope (%)	1.8	N/A	Clear Space to XWalk (in)	N/A
N/A	Any Obstructions?	N/A	N/A	Storm Grate/Utility Hazard?	N/A
	Obstruction Type			Storm Grate/Utility Type	
		N/A			N/A
		Yes		Surface Condition? (G/P)	Good

Remove & Replace Curb Ramp With Two New Directional Ramps or Equivalent.

Total Cost: \$ 3200.00
