Access Compliance Report

Public Rights-of-Way

(Curb Ramps)

Intersection ID: 10770	Main Street: ALICE_AV	Cross Street: TUCKASEEGEE_RD	Location: S
ADA ID: 093AE7D112C5	Ramp Type: Perp	Initial Pass/Fail: Fail	Overall Compliance: No
Severity Score: 10			
Codes/Mitigation Info/Possible Solution		Field Measurements/Component Compliance

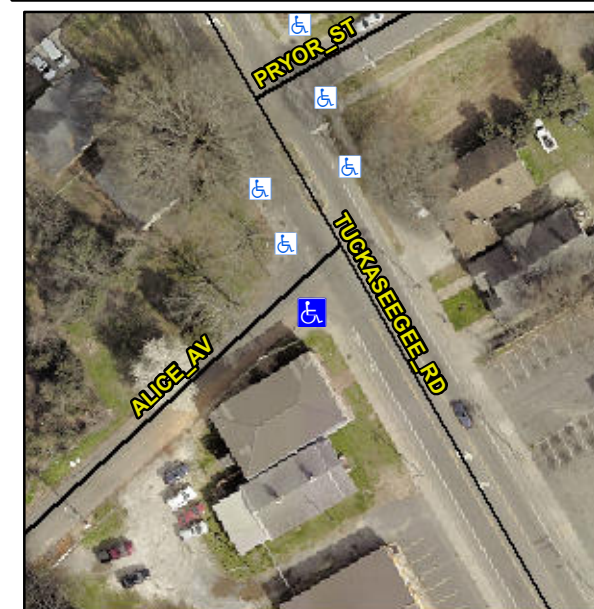
Not Found, R304.5.1, R304.5.3

Compliance	Description	Data	Compliance	Description	Data
N/A	Ramp Length (in)	72.0	Yes	Ramp Slope (%)	7.0
No	Ramp Width (in)	47.0	No	Ramp XSlope (%)	3.3
N/A	Flare Type LT	N/A	N/A	Flare Type RT	N/A
N/A	Flare Slope LT (%)	N/A	N/A	Flare Slope RT (%)	N/A
N/A	Flare Traversable LT?	N/A	N/A	Flare Traversable RT?	N/A
N/A	Landing Length (in)	N/A	N/A	DWS Provided?	N/A
N/A	Landing Width (in)	N/A	N/A	DWS Contrast?	N/A
N/A	Landing Slope (%)	N/A	N/A	DWS Length (in)	N/A
N/A	Landing X Slope (%)	N/A	N/A	DWS Full Width?	N/A
N/A	Landing Curb? (Y/N)	N/A	N/A	DWS Offset (in)	N/A
N/A	Shared Landing?	N/A			
N/A	Gutter Ponding?	N/A	N/A	Gutter Slope (%)	N/A
N/A	Gutter Lip Ht (in)	N/A	N/A	Gutter X Slope (%)	N/A
N/A	Painted X Walk1?	No	N/A	Painted X Walk2?	N/A
	X Walk 1 Direction	To N		X Walk 2 Direction	N/A
N/A	X Walk 1 Width (in)	N/A	N/A	X Walk 2 Width (in)	N/A
	X Walk 1 Slope (%)	5.5		X Walk 2 Slope (%)	N/A
	X Walk 1 X Slope (%)	0.6		X Walk 2 X Slope (%)	N/A

N/A	Ramp inside XWalk1?	N/A	N/A	Ramp inside XWalk2?	N/A
	Road Slope (%)	N/A	N/A	Clear Space?	N/A
	Road X Slope (%)	N/A	N/A	Clear Space to XWalk (in)	N/A
N/A	Any Obstructions?	N/A	N/A	Storm Grate/Utility Hazard?	N/A
	Obstruction Type			Storm Grate/Utility Type	
		N/A			N/A
			Yes	Surface Condition? (G/P)	Good

Remove & Replace Entire Ramp.
