# Access Compliance Report

## Public Rights-of-Way

| Intersection ID: 12517 | Main Street: N_SHARON_AMITY_RD | Cross Street: SHAMROCK_DR | Location: N |
| ADA ID: 0944F323D893 | Ramp Type: Perp | Initial Pass/Fail: Fail | Overall Compliance: No |

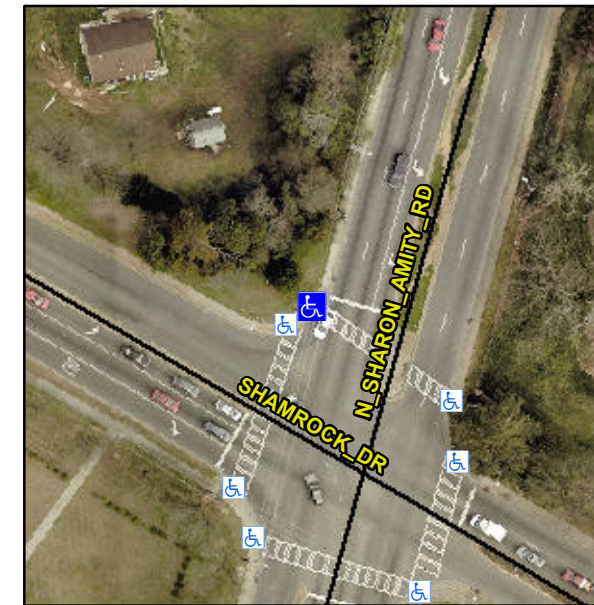
**Not Found, R304.2.2, R304.5.3**

| Compliance | Description | Data | Compliance | Description | Data |
|---|---|---|---|---|---|
| N/A | Ramp Length (in) | 60.0 | No | Ramp Slope (%) | 10.3 |
| Yes | Ramp Width (in) | 48.0 | No | Ramp XSlope (%) | 4.0 |
| | | | Yes | Surface Condition? (G/P) | Good |

**Remove & Replace Entire Ramp.**

Total Cost: \$ 1850.00
