Access Compliance Report

Public Rights-of-Way

(Curb Ramps)

Intersection ID: 8316	Main Street: STATESVILLE_AV	Cross Street: NORTHERLY_RD	Location: SE
ADA ID: 094D15928FA7	Ramp Type: Perp	Initial Pass/Fail: Fail	Overall Compliance: No
Codes/Mitigation Info/Possible Solution			Severity Score: 30
			Field Measurements/Component Compliance

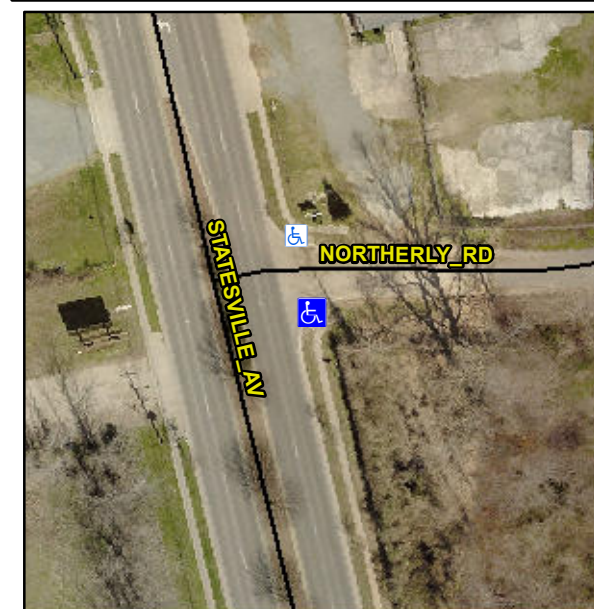
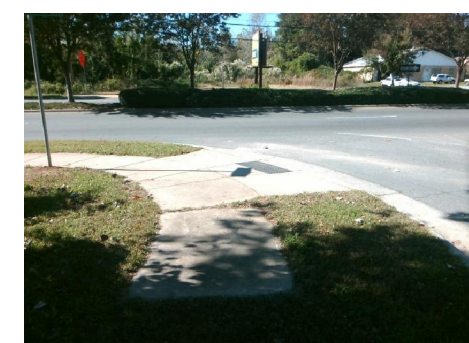
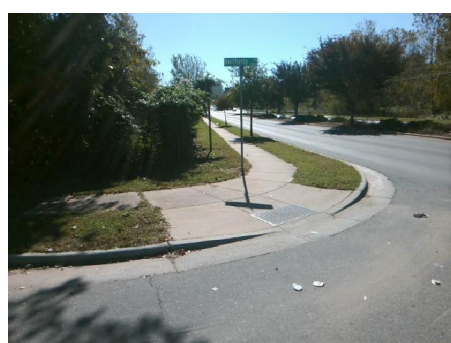
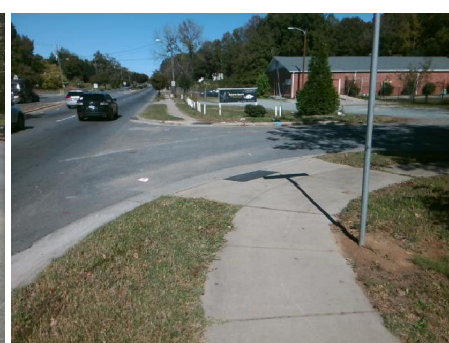
Not Found, R304.5.1, R304.2.2

Compliance	Description	Data	Compliance	Description	Data
N/A	Ramp Length (in)	60.0	No	Ramp Slope (%)	8.9
No	Ramp Width (in)	33.5	Yes	Ramp XSlope (%)	1.9
N/A	Flare Type LT	N/A	N/A	Flare Type RT	N/A
N/A	Flare Slope LT (%)	N/A	N/A	Flare Slope RT (%)	N/A
N/A	Flare Traversable LT?	N/A	N/A	Flare Traversable RT?	N/A
N/A	Landing Length (in)	N/A	N/A	DWS Provided?	N/A
N/A	Landing Width (in)	N/A	N/A	DWS Contrast?	N/A
N/A	Landing Slope (%)	N/A	N/A	DWS Length (in)	N/A
N/A	Landing X Slope (%)	N/A	N/A	DWS Full Width?	N/A
N/A	Landing Curb? (Y/N)	N/A	N/A	DWS Offset (in)	N/A
N/A	Shared Landing?	N/A			
N/A	Gutter Ponding?	N/A	N/A	Gutter Slope (%)	N/A
N/A	Gutter Lip Ht (in)	N/A	N/A	Gutter X Slope (%)	N/A
N/A	Painted X Walk1?	No	N/A	Painted X Walk2?	N/A
	X Walk 1 Direction	To N		X Walk 2 Direction	N/A
N/A	X Walk 1 Width (in)	N/A	N/A	X Walk 2 Width (in)	N/A
	X Walk 1 Slope (%)	1.2		X Walk 2 Slope (%)	N/A
	X Walk 1 X Slope (%)	0.6		X Walk 2 X Slope (%)	N/A

N/A	Ramp inside XWalk1?	N/A	N/A	Ramp inside XWalk2?	N/A
	Road Slope (%)	N/A	N/A	Clear Space?	N/A
	Road X Slope (%)	N/A	N/A	Clear Space to XWalk (in)	N/A
N/A	Any Obstructions?	N/A	N/A	Storm Grate/Utility Hazard?	N/A
	Obstruction Type			Storm Grate/Utility Type	
		N/A			N/A
			Yes	Surface Condition? (G/P)	Good

Possible Solutions:

Remove & Replace Entire Ramp.
