Access Compliance Report

Public Rights-of-Way

(Curb Ramps)

Intersection ID: N/A	Main Street: ROCK_ISLAND_RD	Cross Street: AGNEW_DR	Location: SE
ADA ID: 094F747B2221	Ramp Type: Perp	Initial Pass/Fail: Fail	Overall Compliance: No
		Severity Score: 25

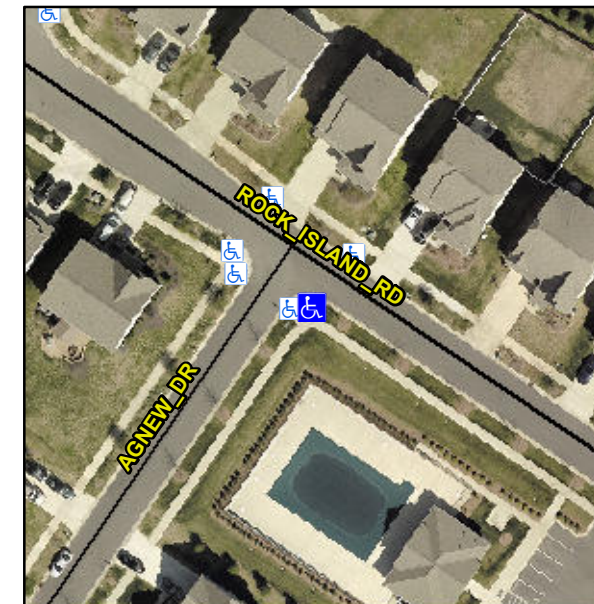
Not Found, R304.5.3

Compliance	Description	Data	Compliance	Description	Data
N/A	Ramp Length (in)	105.0	Yes	Ramp Slope (%)	6.0
Yes	Ramp Width (in)	48.0	No	Ramp XSlope (%)	8.0
N/A	Flare Type LT	N/A	N/A	Flare Type RT	N/A
N/A	Flare Slope LT (%)	N/A	N/A	Flare Slope RT (%)	N/A
N/A	Flare Traversable LT?	N/A	N/A	Flare Traversable RT?	N/A
N/A	Landing Length (in)	N/A	N/A	DWS Provided?	N/A
N/A	Landing Width (in)	N/A	N/A	DWS Contrast?	N/A
N/A	Landing Slope (%)	N/A	N/A	DWS Length (in)	N/A
N/A	Landing X Slope (%)	N/A	N/A	DWS Full Width?	N/A
N/A	Landing Curb? (Y/N)	N/A	N/A	DWS Offset (in)	N/A
N/A	Shared Landing?	N/A			
N/A	Gutter Ponding?	N/A	N/A	Gutter Slope (%)	N/A
N/A	Gutter Lip Ht (in)	N/A	N/A	Gutter X Slope (%)	N/A
N/A	Painted X Walk1?	No	N/A	Painted X Walk2?	N/A
	X Walk 1 Direction	To NE		X Walk 2 Direction	N/A
N/A	X Walk 1 Width (in)	N/A	N/A	X Walk 2 Width (in)	N/A
	X Walk 1 Slope (%)	2.7		X Walk 2 Slope (%)	N/A
	X Walk 1 X Slope (%)	8.7		X Walk 2 X Slope (%)	N/A

N/A	Ramp inside XWalk1?	N/A	N/A	Ramp inside XWalk2?	N/A
	Road Slope (%)	N/A	N/A	Clear Space?	N/A
	Road X Slope (%)	N/A	N/A	Clear Space to XWalk (in)	N/A
N/A	Any Obstructions?	N/A	N/A	Storm Grate/Utility Hazard?	N/A
	Obstruction Type			Storm Grate/Utility Type	
		N/A			N/A
			Yes	Surface Condition? (G/P)	Good

Remove & Replace Entire Ramp.

Total Cost: \$ 1850.00
