Access Compliance Report

Public Rights-of-Way

(Curb Ramps)

Intersection ID: 47670	Main Street: COLLINGHAM_DR	Cross Street: FENWAY_DR	Location: SW
ADA ID: 095332260ED9	Ramp Type: Perp	Initial Pass/Fail: Fail	Overall Compliance: No
Severity Score: 10			
Codes/Mitigation Info/Possible Solution		Field Measurements/Component Compliance

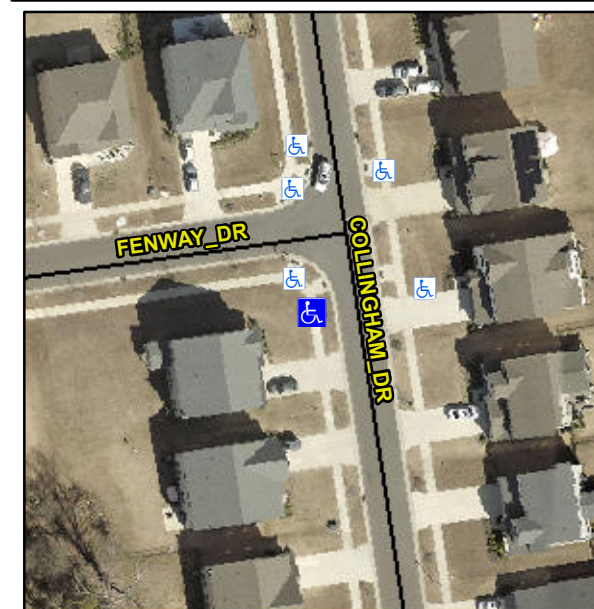
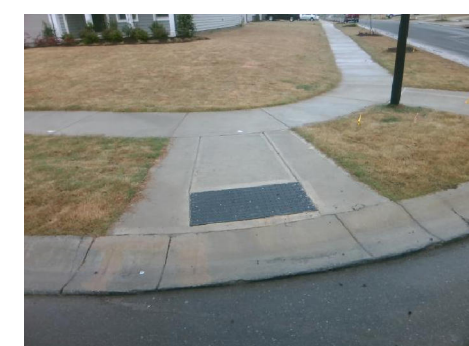
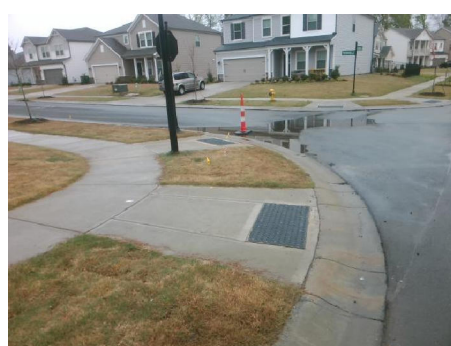
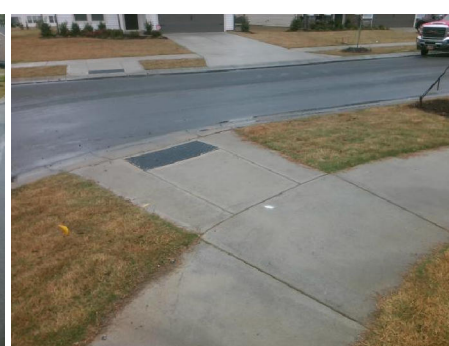
Not Found, R304.5.1, R304.5.3

Compliance	Description	Data	Compliance	Description	Data
N/A	Ramp Length (in)	95.0	Yes	Ramp Slope (%)	5.4
No	Ramp Width (in)	37.0	No	Ramp XSlope (%)	2.6
N/A	Flare Type LT	N/A	N/A	Flare Type RT	N/A
N/A	Flare Slope LT (%)	N/A	N/A	Flare Slope RT (%)	N/A
N/A	Flare Traversable LT?	N/A	N/A	Flare Traversable RT?	N/A
N/A	Landing Length (in)	N/A	N/A	DWS Provided?	N/A
N/A	Landing Width (in)	N/A	N/A	DWS Contrast?	N/A
N/A	Landing Slope (%)	N/A	N/A	DWS Length (in)	N/A
N/A	Landing X Slope (%)	N/A	N/A	DWS Full Width?	N/A
N/A	Landing Curb? (Y/N)	N/A	N/A	DWS Offset (in)	N/A
N/A	Shared Landing?	N/A			
N/A	Gutter Ponding?	N/A	N/A	Gutter Slope (%)	N/A
N/A	Gutter Lip Ht (in)	N/A	N/A	Gutter X Slope (%)	N/A
N/A	Painted X Walk1?	No	N/A	Painted X Walk2?	N/A
	X Walk 1 Direction	To E		X Walk 2 Direction	N/A
N/A	X Walk 1 Width (in)	N/A	N/A	X Walk 2 Width (in)	N/A
	X Walk 1 Slope (%)	2.7		X Walk 2 Slope (%)	N/A
	X Walk 1 X Slope (%)	0.9		X Walk 2 X Slope (%)	N/A

N/A	Ramp inside XWalk1?	N/A	N/A	Ramp inside XWalk2?	N/A
	Road Slope (%)	N/A	N/A	Clear Space?	N/A
	Road X Slope (%)	N/A	N/A	Clear Space to XWalk (in)	N/A
N/A	Any Obstructions?	N/A	N/A	Storm Grate/Utility Hazard?	N/A
	Obstruction Type			Storm Grate/Utility Type	
		N/A			N/A
		Yes		Surface Condition? (G/P)	Good

Remove & Replace Entire Ramp.
