Access Compliance Report

Public Rights-of-Way

(Curb Ramps)

Intersection ID: 43116	Main Street: CENTRAL_AV	Cross Street: PECAN_AV	Location: SE
ADA ID: 0954B461FBC9	Ramp Type: Perp	Initial Pass/Fail: Fail	Overall Compliance: No
		Severity Score: 12.5

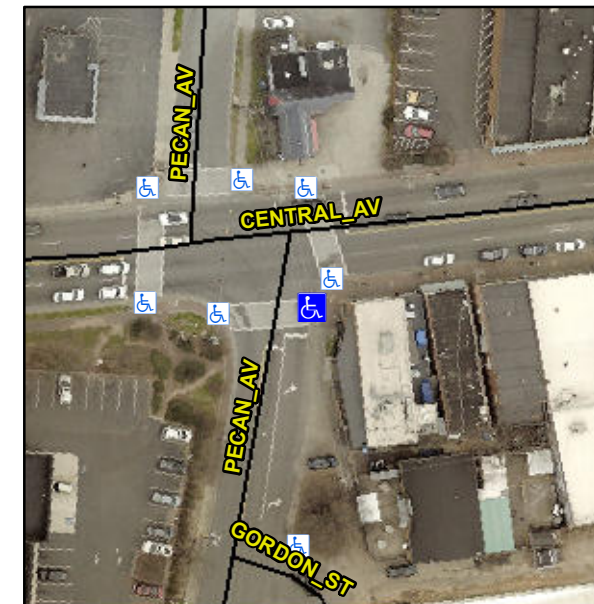
Not Found, R304.2.2

Compliance	Description	Data	Compliance	Description	Data
N/A	Ramp Length (in)	69.0	No	Ramp Slope (%)	8.4
Yes	Ramp Width (in)	48.0	Yes	Ramp XSlope (%)	1.6
N/A	Flare Type LT	N/A	N/A	Flare Type RT	N/A
N/A	Flare Slope LT (%)	N/A	N/A	Flare Slope RT (%)	N/A
N/A	Flare Traversable LT?	N/A	N/A	Flare Traversable RT?	N/A
N/A	Landing Length (in)	N/A	N/A	DWS Provided?	N/A
N/A	Landing Width (in)	N/A	N/A	DWS Contrast?	N/A
N/A	Landing Slope (%)	N/A	N/A	DWS Length (in)	N/A
N/A	Landing X Slope (%)	N/A	N/A	DWS Full Width?	N/A
N/A	Landing Curb? (Y/N)	N/A	N/A	DWS Offset (in)	N/A
N/A	Shared Landing?	N/A			
N/A	Gutter Ponding?	N/A	N/A	Gutter Slope (%)	N/A
N/A	Gutter Lip Ht (in)	N/A	N/A	Gutter X Slope (%)	N/A
N/A	Painted X Walk1?	Yes	N/A	Painted X Walk2?	N/A
	X Walk 1 Direction	To W		X Walk 2 Direction	N/A
N/A	X Walk 1 Width (in)	145.0	N/A	X Walk 2 Width (in)	N/A
	X Walk 1 Slope (%)	3.5		X Walk 2 Slope (%)	N/A
	X Walk 1 X Slope (%)	1.3		X Walk 2 X Slope (%)	N/A

N/A	Ramp inside XWalk1?	Yes	N/A	Ramp inside XWalk2?	N/A
	Road Slope (%)	N/A	N/A	Clear Space?	N/A
	Road X Slope (%)	N/A	N/A	Clear Space to XWalk (in)	N/A
N/A	Any Obstructions?	N/A	N/A	Storm Grate/Utility Hazard?	N/A
	Obstruction Type			Storm Grate/Utility Type	
		N/A			N/A
			Yes	Surface Condition? (G/P)	Good

Remove & Replace Entire Ramp.
