Access Compliance Report Public Rights-of-Way (Curb Ramps)

Intersection ID: 24040 Main Street: FOX_CHAPEL_LN Cross Street: HAWK_CREST_CT Location: N

ADA ID: 0971DE53CA3B Ramp Type: BlendTrans1 Initial Pass/Fail: Fail Overall Compliance: No Severity Score: 25

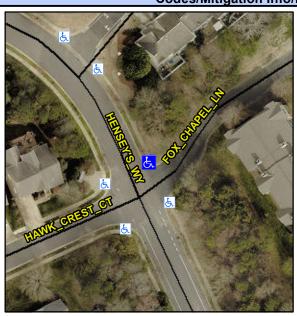
Fleid Measurements/Component Compliance						
Compliance Description		Data	Comp	liance Description	Data	
ı	N/A	Ramp Length (in)	50.0	Yes	BlendTrans Slope (%)	1.2
,	Yes	Ramp Width (in)	48.0	No	BlendTrans XSlope (%)	11.1
ı	N/A	Flare Type LT	N/A	N/A	Flare Type RT	N/A
ı	N/A	Flare Slope LT (%)	N/A	N/A	Flare Slope RT (%)	N/A
ı	N/A	Flare Traversable LT?	N/A	N/A	Flare Traversable RT?	N/A
I	N/A	Landing Length (in)	N/A	N/A	DWS Provided?	N/A
I	N/A	Landing Width (in)	N/A	N/A	DWS Contrast?	N/A
I	N/A	Landing Slope (%)	N/A	N/A	DWS Length (in)	N/A
ı	N/A	Landing X Slope (%)	N/A	N/A	DWS Full Width?	N/A
ı	N/A	Landing Curb? (Y/N)	N/A	N/A	DWS Offset (in)	N/A
ı	N/A	Shared Landing?	N/A			
I	N/A	Gutter Ponding?	N/A	N/A	Gutter Slope (%)	N/A
ı	N/A	Gutter Lip Ht (in)	N/A	N/A	Gutter X Slope (%)	N/A
ı	N/A	Painted X Walk1?	No	N/A	Painted X Walk2?	No
		X Walk 1 Direction	To SW		X Walk 2 Direction	To SE
		X Walk 1 Width (in)	N/A		X Walk 2 Width (in)	N/A

X Walk 1 Slope (%)	3.4		X Walk 2 Slope (%)	1.0
		X Walk 1 X Slope (%)	2.1		X Walk 2 X Slope (%)	9.4
ı	N/A	Ramp inside XWalk1?	N/A	N/A	Ramp inside XWalk2?	N/A
		Road Slope (%)	8.2		Clear Space?	N/A
		Road X Slope (%)	5.1	N/A	Clear Space to XWalk (in)	N/A
ı	N/A	Any Obstructions?	N/A	N/A	Storm Grate/Utility Hazard?	N/A
		Obstruction Type			Storm Grate/Utility Type

Remove & Replace Curb Ramp With Two New Directional Ramps or Equivalent.
