Access Compliance Report

Public Rights-of-Way

(Curb Ramps)

Intersection ID: 14757	Main Street: E_WORTHINGTON_AV	Cross Street: LENNOX_AV	Location:	N
ADA ID: 0980450E2C97	Ramp Type: Perp	Initial Pass/Fail: Fail	Overall Compliance: No	Severity Score: 12.5
Codes/Mitigation Info/Possible Solution		Field Measurements/Component Compliance

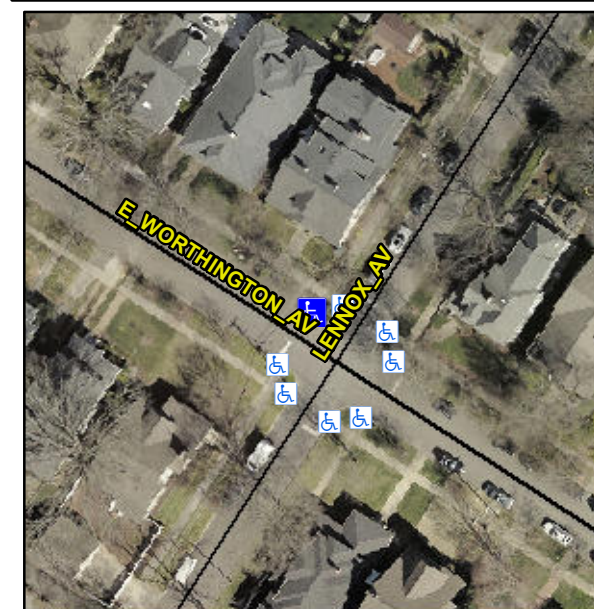
Not Found, R304.2.2

Compliance	Description	Data	Compliance	Description	Data
N/A	Ramp Length (in)	109.0	No	Ramp Slope (%)	8.8
Yes	Ramp Width (in)	59.0	Yes	Ramp XSlope (%)	2.0
N/A	Flare Type LT	N/A	N/A	Flare Type RT	N/A
N/A	Flare Slope LT (%)	N/A	N/A	Flare Slope RT (%)	N/A
N/A	Flare Traversable LT?	N/A	N/A	Flare Traversable RT?	N/A
N/A	Landing Length (in)	N/A	N/A	DWS Provided?	N/A
N/A	Landing Width (in)	N/A	N/A	DWS Contrast?	N/A
N/A	Landing Slope (%)	N/A	N/A	DWS Length (in)	N/A
N/A	Landing X Slope (%)	N/A	N/A	DWS Full Width?	N/A
N/A	Landing Curb? (Y/N)	N/A	N/A	DWS Offset (in)	N/A
N/A	Shared Landing?	N/A			
N/A	Gutter Ponding?	N/A	N/A	Gutter Slope (%)	N/A
N/A	Gutter Lip Ht (in)	N/A	N/A	Gutter X Slope (%)	N/A
N/A	Painted X Walk1?	No	N/A	Painted X Walk2?	N/A
	X Walk 1 Direction	To SW		X Walk 2 Direction	N/A
N/A	X Walk 1 Width (in)	N/A	N/A	X Walk 2 Width (in)	N/A
	X Walk 1 Slope (%)	3.5		X Walk 2 Slope (%)	N/A
	X Walk 1 X Slope (%)	0.1		X Walk 2 X Slope (%)	N/A

N/A	Ramp inside XWalk1?	N/A	N/A	Ramp inside XWalk2?	N/A
	Road Slope (%)	N/A	N/A	Clear Space?	N/A
	Road X Slope (%)	N/A	N/A	Clear Space to XWalk (in)	N/A
N/A	Any Obstructions?	N/A	N/A	Storm Grate/Utility Hazard?	N/A
	Obstruction Type			Storm Grate/Utility Type	
		N/A			N/A
			Yes	Surface Condition? (G/P)	Good

Possible Solutions:

Remove & Replace Entire Ramp.

Total Cost: \$ 1850.00
