Access Compliance Report

Public Rights-of-Way

(Curb Ramps)

Intersection ID: 25757	Main Street: BANNINGTON_RD	Cross Street: SHANNON_WILLOW_RD	Location: NE
ADA ID: 09882A0CA437	Ramp Type: PerpDiag	Initial Pass/Fail: Fail	Overall Compliance: No
Severity Score: 12.5			
Codes/Mitigation Info/Possible Solution		Field Measurements/Component Compliance

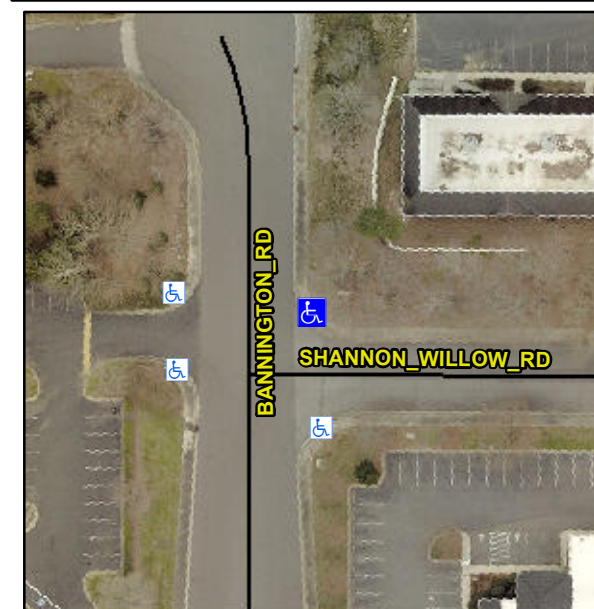
Compliance	Description	Data	Compliance	Description	Data
N/A	Ramp Length (in)	62.0	No	Ramp Slope (%)	8.5
Yes	Ramp Width (in)	48.0	Yes	Ramp XSlope (%)	0.9
N/A	Flare Type LT	N/A	N/A	Flare Type RT	N/A
N/A	Flare Slope LT (%)	N/A	N/A	Flare Slope RT (%)	N/A
N/A	Flare Traversable LT?	N/A	N/A	Flare Traversable RT?	N/A
N/A	Landing Length (in)	N/A	N/A	DWS Provided?	N/A
N/A	Landing Width (in)	N/A	N/A	DWS Contrast?	N/A
N/A	Landing Slope (%)	N/A	N/A	DWS Length (in)	N/A
N/A	Landing X Slope (%)	N/A	N/A	DWS Full Width?	N/A
N/A	Landing Curb? (Y/N)	N/A	N/A	DWS Offset (in)	N/A
N/A	Shared Landing?	N/A			
N/A	Gutter Ponding?	N/A	N/A	Gutter Slope (%)	N/A
N/A	Gutter Lip Ht (in)	N/A	N/A	Gutter X Slope (%)	N/A
N/A	Painted X Walk1?	No	N/A	Painted X Walk2?	No
	X Walk 1 Direction	To W		X Walk 2 Direction	To S
N/A	X Walk 1 Width (in)	N/A	N/A	X Walk 2 Width (in)	N/A
	X Walk 1 Slope (%)	3.9		X Walk 2 Slope (%)	1.1
	X Walk 1 X Slope (%)	0.8		X Walk 2 X Slope (%)	4.5

N/A	Ramp inside XWalk1?	N/A	N/A	Ramp inside XWalk2?	N/A
	Road Slope (%)	0.3	N/A	Clear Space?	N/A
	Road X Slope (%)	5.1	N/A	Clear Space to XWalk (in)	N/A
N/A	Any Obstructions?	N/A	N/A	Storm Grate/Utility Hazard?	N/A
	Obstruction Type			Storm Grate/Utility Type	
		N/A			N/A
		Yes		Surface Condition? (G/P)	Good

Remove & Replace Curb Ramp With Two New Directional Ramps or Equivalent.

R304.2.2

\$ 3200.00
