# Access Compliance Report

## Public Rights-of-Way

### (Curb Ramps)

| Intersection ID: 44062 | Main Street: WESTMILL_LN | Cross Street: SEDGEMOOR_LN | Location: S |

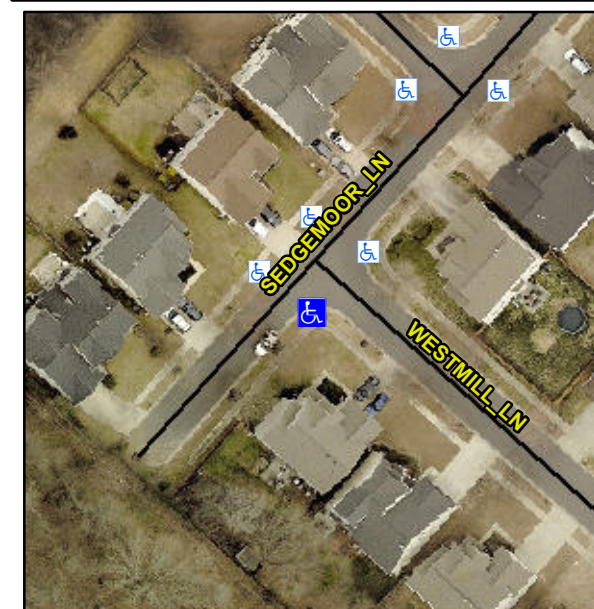
| ADA ID: 09895C7A1105 | Ramp Type: PerpDiag | Initial Pass/Fail: Pass | Overall Compliance: No |
| Severity Score: 4 | | | |

**R304.2.1, R304.2.2-Perp, R304.3.2-Para, R305.2**

| Compliance | Description | Data | Compliance | Description | Data |
|---|---|---|---|---|---|
| No | Landing Length (in) | 47.0 | Yes | DWS Provided? | Yes |
| No | Landing Width (in) | 43.0 | Yes | DWS Contrast? | Yes |
| No | Landing Slope (%) | 3.1 | Yes | DWS Length (in) | 24.0 |
| N/A | Landing Curb? (Y/N) | No | No | DWS Offset (in) | 4.0 |

**Remove & Replace Curb Ramp With Two New Directional Ramps or Equivalent.**

Total Cost: \$ 3200.00
