Access Compliance Report

Public Rights-of-Way

(Curb Ramps)

Intersection ID: 27254	Main Street: PIPER_STATION_DR	Cross Street: SPINDLETOP_PL	Location: SE
ADA ID: 0992C257E501	Ramp Type: Perp	Initial Pass/Fail: Fail	Overall Compliance: No
Severity Score: 33.75			
Codes/Mitigation Info/Possible Solution		Field Measurements/Component Compliance

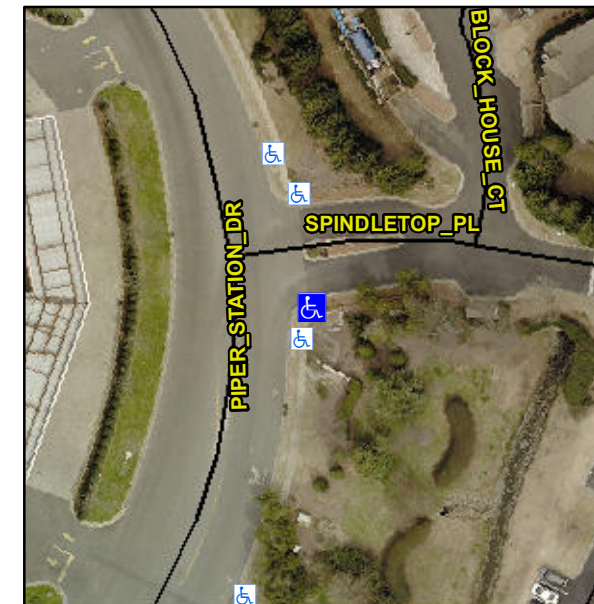
R304.5.1, R304.2.2, R304.5.3

Compliance	Description	Data	Compliance	Description	Data
N/A	Ramp Length (in)	50.0	No	Ramp Slope (%)	8.5
No	Ramp Width (in)	46.5	No	Ramp XSlope (%)	6.4
N/A	Flare Type LT	N/A	N/A	Flare Type RT	N/A
N/A	Flare Slope LT (%)	N/A	N/A	Flare Slope RT (%)	N/A
N/A	Flare Traversable LT?	N/A	N/A	Flare Traversable RT?	N/A
N/A	Landing Length (in)	N/A	N/A	DWS Provided?	N/A
N/A	Landing Width (in)	N/A	N/A	DWS Contrast?	N/A
N/A	Landing Slope (%)	N/A	N/A	DWS Length (in)	N/A
N/A	Landing X Slope (%)	N/A	N/A	DWS Full Width?	N/A
N/A	Landing Curb? (Y/N)	N/A	N/A	DWS Offset (in)	N/A
N/A	Shared Landing?	N/A			
N/A	Gutter Ponding?	N/A	N/A	Gutter Slope (%)	N/A
N/A	Gutter Lip Ht (in)	N/A	N/A	Gutter X Slope (%)	N/A
N/A	Painted X Walk1?	No	N/A	Painted X Walk2?	N/A
	X Walk 1 Direction	To N		X Walk 2 Direction	N/A
N/A	X Walk 1 Width (in)	N/A	N/A	X Walk 2 Width (in)	N/A
	X Walk 1 Slope (%)	2.5		X Walk 2 Slope (%)	N/A
	X Walk 1 X Slope (%)	3.6		X Walk 2 X Slope (%)	N/A

Possible Solutions:

Remove & Replace Entire Ramp.
