Access Compliance Report

Public Rights-of-Way

(Curb Ramps)

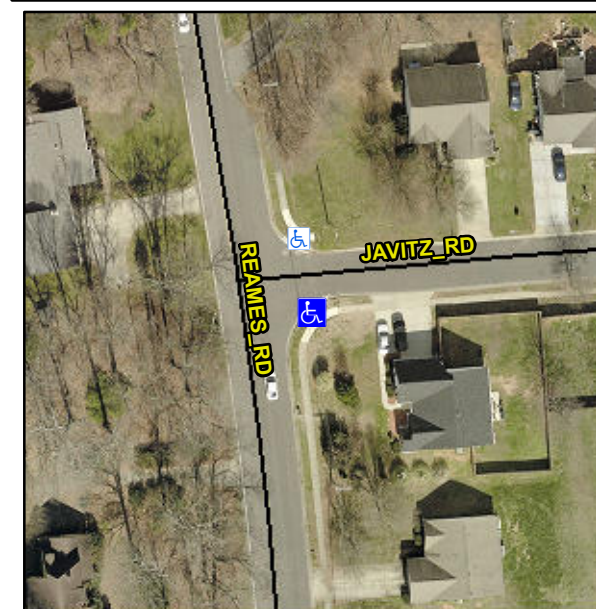
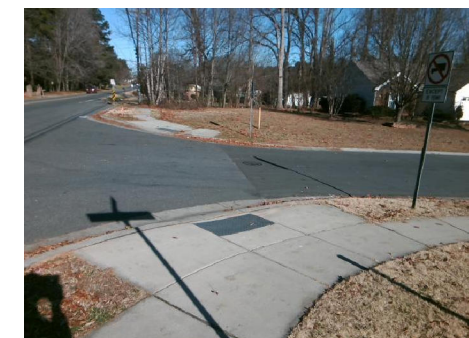
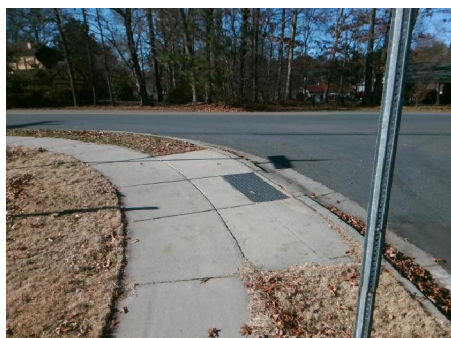
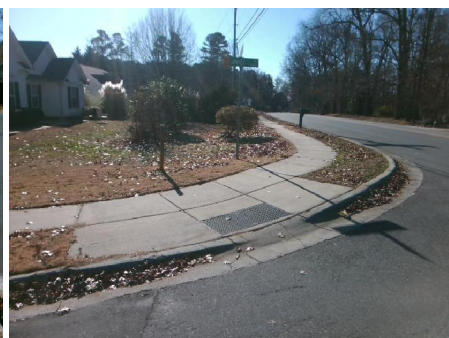
Intersection ID: 42387	Main Street: JAVITZ_RD	Cross Street: REAMES_RD	Location: SE
ADA ID: 09972E508A3F	Ramp Type: Combination1	Initial Pass/Fail: Fail	Overall Compliance: No
Codes/Mitigation Info/Possible Solution		Field Measurements/Component Compliance	
Severity Score: 33.75

GTR GAP 2.0, RP < 5%

Not Found, R304.5.1, R304.5.1, R304.5.3

Compliance	Description	Data	Compliance	Description	Data
N/A	Ramp Length LT (in)	48.5	N/A	Ramp Length RT (in)	49.5
No	Ramp Width LT (in)	46.0	No	Ramp Width RT (in)	46.5
Yes	Ramp Slope LT (%)	6.7	Yes	Ramp Slope RT (%)	6.4
Yes	Ramp XSlope LT (%)	0.4	Yes	Ramp XSlope RT (%)	1.3
N/A	Ramp Length (in)	49.0	Yes	Ramp Slope (%)	2.1
No	Ramp Width (in)	47.0	No	Ramp XSlope (%)	11.7
N/A	Flare Type LT	N/A	N/A	Flare Type RT	N/A
N/A	Flare Slope LT (%)	N/A	N/A	Flare Slope RT (%)	N/A
N/A	Flare Traversable LT?	N/A	N/A	Flare Traversable RT?	N/A
N/A	Landing Length (in)	N/A	N/A	DWS Provided?	N/A
N/A	Landing Width (in)	N/A	N/A	DWS Contrast?	N/A
N/A	Landing Slope (%)	N/A	N/A	DWS Length (in)	N/A
N/A	Landing X Slope (%)	N/A	N/A	DWS Full Width?	N/A
N/A	Landing Curb? (Y/N)	N/A	N/A	DWS Offset (in)	N/A
N/A	Shared Landing?	N/A			
N/A	Gutter Ponding?	N/A	N/A	Gutter Slope (%)	N/A
N/A	Gutter Lip Ht (in)	N/A	N/A	Gutter X Slope (%)	N/A
N/A	Painted X Walk1?	No	N/A	Painted X Walk2?	N/A

X Walk 1 Direction	To NE		X Walk 2 Direction	N/A
	X Walk 1 Width (in)	N/A		X Walk 2 Width (in)	N/A
	X Walk 1 Slope (%)	1.7		X Walk 2 Slope (%)	N/A
	X Walk 1 X Slope (%)	7.9		X Walk 2 X Slope (%)	N/A
N/A	Ramp inside XWalk1?	N/A	N/A	Ramp inside XWalk2?	N/A
	Road Slope (%)	N/A		Clear Space?	N/A
	Road X Slope (%)	N/A	N/A	Clear Space to XWalk (in)	N/A
			N/A	Any Obstruction?	N/A
				Obstruction Type	N/A
			N/A	Storm Grate/Utility Hazard?	N/A
				Storm Grate/Utility Type	N/A
			Yes	Surface Condition? (G/P)	Good
				Curb Slope (%)	32.4

Remove & Replace Entire Ramp.

Total Cost: \$ 1800.00
