Access Compliance Report

Public Rights-of-Way

(Curb Ramps)

Intersection ID: 10031127	Main Street: MARGARET_WALLACE_RD	Cross Street: N/A	Location: NW
ADA ID: 0997C3C10855	Ramp Type: PerpDiag	Initial Pass/Fail: Fail	Overall Compliance: No
Severity Score: 47.5			
Codes/Mitigation Info/Possible Solution		Field Measurements/Component Compliance

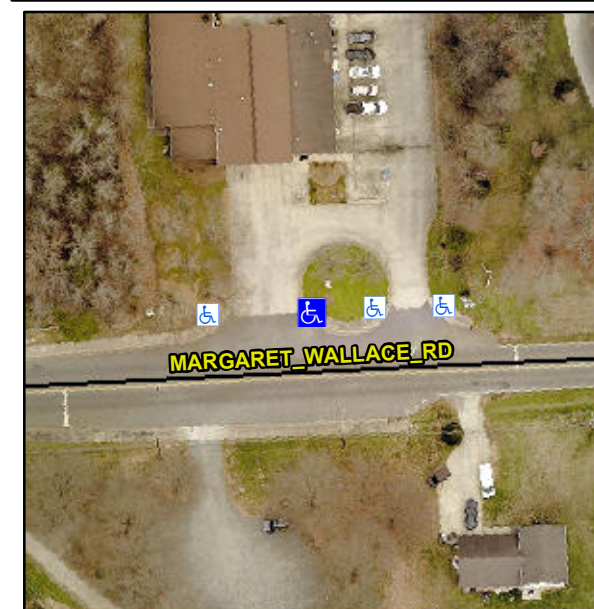
Not Found, R304.5.1, R304.2.2

Compliance	Description	Data	Compliance	Description	Data
N/A	Ramp Length (in)	58.5	No	Ramp Slope (%)	8.7
No	Ramp Width (in)	24.0	Yes	Ramp XSlope (%)	0.1
N/A	Flare Type LT	N/A	N/A	Flare Type RT	N/A
N/A	Flare Slope LT (%)	N/A	N/A	Flare Slope RT (%)	N/A
N/A	Flare Traversable LT?	N/A	N/A	Flare Traversable RT?	N/A
N/A	Landing Length (in)	N/A	N/A	DWS Provided?	N/A
N/A	Landing Width (in)	N/A	N/A	DWS Contrast?	N/A
N/A	Landing Slope (%)	N/A	N/A	DWS Length (in)	N/A
N/A	Landing X Slope (%)	N/A	N/A	DWS Full Width?	N/A
N/A	Landing Curb? (Y/N)	N/A	N/A	DWS Offset (in)	N/A
N/A	Shared Landing?	N/A			
N/A	Gutter Ponding?	N/A	N/A	Gutter Slope (%)	N/A
N/A	Gutter Lip Ht (in)	N/A	N/A	Gutter X Slope (%)	N/A
N/A	Painted X Walk1?	No	N/A	Painted X Walk2?	No
	X Walk 1 Direction	To E		X Walk 2 Direction	To S
N/A	X Walk 1 Width (in)	N/A	N/A	X Walk 2 Width (in)	N/A
	X Walk 1 Slope (%)	0.2		X Walk 2 Slope (%)	0.5
	X Walk 1 X Slope (%)	2.4		X Walk 2 X Slope (%)	1.9

N/A	Ramp inside XWalk1?	N/A	N/A	Ramp inside XWalk2?	N/A
	Road Slope (%)	0.2	N/A	Clear Space?	N/A
	Road X Slope (%)	0.4	N/A	Clear Space to XWalk (in)	N/A
N/A	Any Obstructions?	N/A	N/A	Storm Grate/Utility Hazard?	N/A
	Obstruction Type			Storm Grate/Utility Type	
		N/A			N/A
			Yes	Surface Condition? (G/P)	Good

Possible Solutions:

Remove & Replace Curb Ramp With Two New Directional Ramps or Equivalent.

Total Cost: \$ 3200.00
