Access Compliance Report Public Rights-of-Way (Curb Ramps)

Intersection ID: 16151 Main Street: FREELAND_LN Cross Street: S_TRYON_ST Location: S **Overall Compliance: No ADA ID: 09AC3E9ED199** Ramp Type: Perp Initial Pass/Fail: Fail **Severity Score:** 22.5

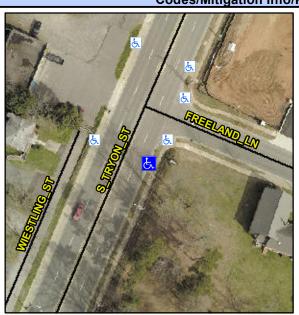
Field Measurements/Component Compliance								
Compl	iance Description	Data	Comp	liance	Description	Data		
N/A	Ramp Length (in)	48.0	No	Ramp	Slope (%)	11.8		
No	Ramp Width (in)	47.5	No	Ramp	XSlope (%)	3.0		
N/A	Flare Type LT	N/A	N/A	Flare	Type RT	N/A		
N/A	Flare Slope LT (%)	N/A	N/A	Flare	Slope RT (%)	N/A		
N/A	Flare Traversable LT?	N/A	N/A	Flare	Traversable RT?	N/A		
N/A	Landing Length (in)	N/A	N/A	DWS	Provided?	N/A		
N/A	Landing Width (in)	N/A	N/A	DWS	Contrast?	N/A		
N/A	Landing Slope (%)	N/A	N/A	DWS	Length (in)	N/A		
N/A	Landing X Slope (%)	N/A	N/A	DWS	Full Width?	N/A		
N/A	Landing Curb? (Y/N)	N/A	N/A	DWS	Offset (in)	N/A		
N/A	Shared Landing?	N/A						
N/A	Gutter Ponding?	N/A	N/A	Gutte	r Slope (%)	N/A		
N/A	Gutter Lip Ht (in)	N/A	N/A	Gutte	r X Slope (%)	N/A		
N/A	Painted X Walk1?	No	N/A	Painte	ed X Walk2?	N/A		
	X Walk 1 Direction	To NW		X Wa	lk 2 Direction	N/A		
N/A	X Walk 1 Width (in)	N/A	N/A	X Wa	lk 2 Width (in)	N/A

X Walk 1 Slope (%)	3.2		X Wa	lk 2 Slope (%)	N/A		
	X Walk 1 X Slope (%)	2.4		X Wa	lk 2 X Slope (%)	N/A		
N/A	Ramp inside XWalk1?	N/A	N/A	Ramp	inside XWalk2?	N/A		
	Road Slope (%)	N/A	N/A	Clear	Space?	N/A		
	Road X Slope (%)	N/A	N/A	Clear	Space to XWalk (in)	N/A		
N/A	Any Obstructions?	N/A	N/A	Storm	Grate/Utility Hazard?	N/A		
	Obstruction Type			Storm	Grate/Utility Type			
		N/A				N/A		
			Yes	Surfa	ce Condition? (G/P)	Good

Possible Solutions:	9		
Remove & Replace Entire Ramp.			
	N		
	N		
	N		
	1		
	N		
Surveyor Notes:	N		
N/A	N		
	N		
	ı		
	1		
PROW/ADA:	ı		
Not Found, R304.5.1, R304.2.2,	N		
R304.5.3	١		
	١
