# Access Compliance Report

## Public Rights-of-Way (Curb Ramps)

| Intersection ID: 43363 | Main Street: PROSPERITY_VIEW_DR | Cross Street: RIDGEVIEW_COMMONS_DR | Location: | N |
| ADA ID: 09B3B7AB025C | Ramp Type: BlendTrans1 | Initial Pass/Fail: Pass | Overall Compliance: No | Severity Score: 19 |

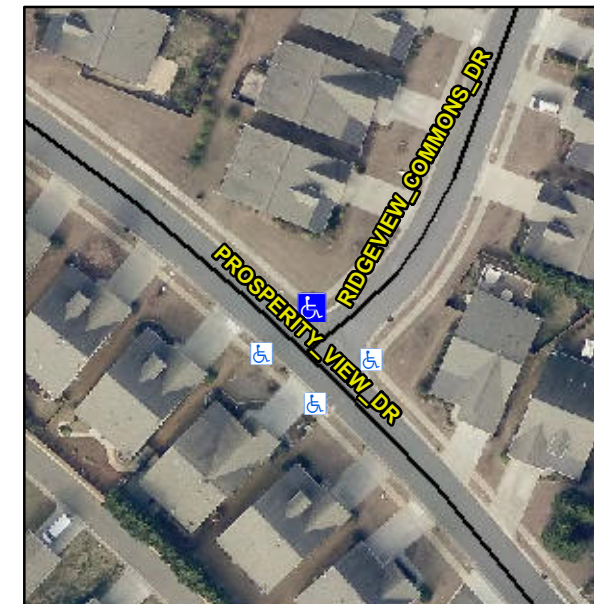
| Compliance | Description | Data | Compliance | Description | Data |
|---|---|---|---|---|---|
| No | Landing Length (in) | 37.0 | Yes | DWS Provided? | Yes |
| No | Landing Width (in) | 46.0 | Yes | DWS Contrast? | Yes |
| No | Landing Slope (%) | 2.7 | Yes | DWS Length (in) | 24.0 |
| N/A | Landing Curb? (Y/N) | No | No | DWS Offset (in) | 2.5 |
| No | Gutter Lip Ht (in) | 1.0 | Yes | Gutter X Slope (%) | 0.1 |

**Remove & Replace Curb Ramp With Two New Directional Ramps or Equivalent. Grind Gutter Lip.**

**R304.2.1, R304.2.2-Perp, R304.3.2-Para, R305.2, R302.7.2**
