Access Compliance Report

Public Rights-of-Way (Curb Ramps)

Intersection ID: N/A	Main Street: ARBOR_LOOP_DR	Cross Street: POTOMAC_RIVER_PY	Location: SE
ADA ID: 09B6B9281B43	Ramp Type: Directional1	Initial Pass/Fail: Fail	Overall Compliance: No
Codes/Mitigation Info/Possible Solution		Field Measurements/Component Compliance	
Severity Score: 1.25

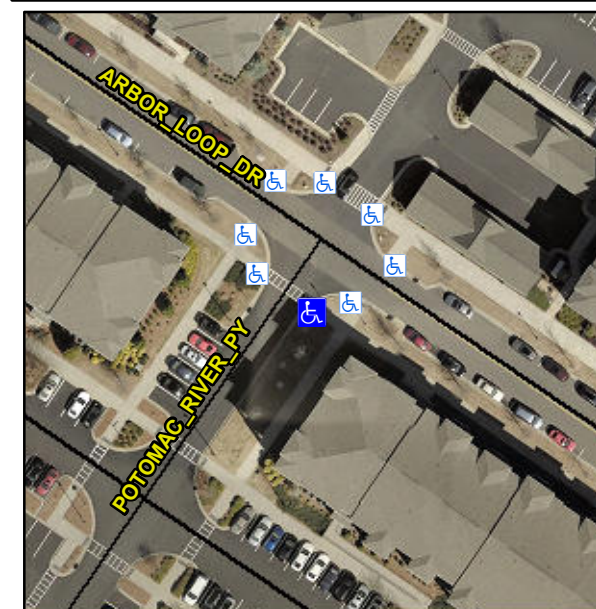
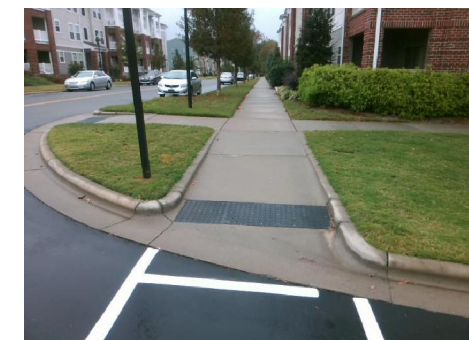
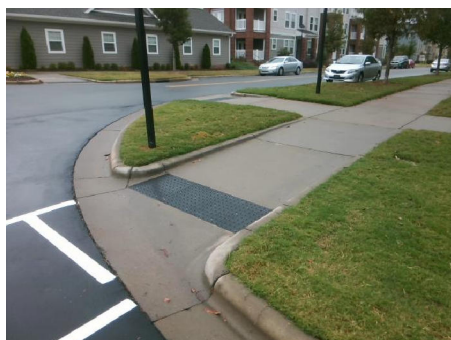
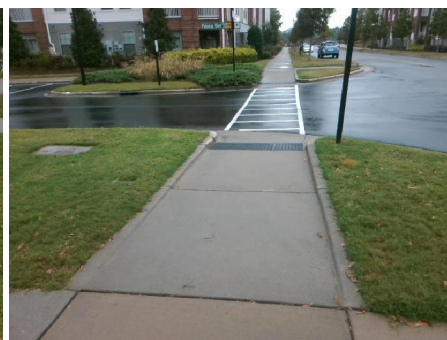
Compliance	Description	Data	Compliance	Description	Data
N/A	Ramp Length (in)	187.0	N/A	Grade Break?	N/A
Yes	Ramp Width (in)	69.0	N/A	Grade Break Slope (%)	0.0
Yes	Ramp Slope (%)	6.4	N/A	Grade Break XSlope (%)	0.0
No	Ramp XSlope (%)	2.6			
N/A	Flare Type LT	N/A	N/A	Flare Type RT	N/A
N/A	Flare Slope LT (%)	N/A	N/A	Flare Slope RT (%)	0.0
N/A	Flare Traversable LT?	N/A	N/A	Flare Traversable RT?	N/A
N/A	Landing Length (in)	0.0	N/A	DWS Provided?	N/A
N/A	Landing Width (in)	0.0	N/A	DWS Contrast?	N/A
N/A	Landing Slope (%)	0.0	N/A	DWS Length (in)	N/A
N/A	Landing X Slope (%)	0.0	N/A	DWS Full Width?	N/A
N/A	Landing Curb? (Y/N)	N/A	N/A	DWS Offset LT (in)	N/A
N/A	Shared Landing?	N/A	N/A	DWS Offset RT (in)	N/A
N/A	Gutter Ponding?	0.0	N/A	Gutter Slope (%)	N/A
N/A	Gutter Lip Ht (in)	0.0	N/A	Gutter X Slope (%)	N/A
N/A	Painted X Walk1?	Yes		Road Slope (%)	0.9
	X Walk 1 Direction	To W		Road X Slope (%)	4.8
	X Walk 1 Width (in)	63.0		Clear Space?	N/A

X Walk 1 Slope (%)	0.9	N/A	Clear Space to XWalk (in)	N/A
	X Walk 1 X Slope (%)	4.8	N/A	Storm Grate/Utility Hazard?	N/A
N/A	Ramp inside XWalk1?	Yes		Storm Grate/Utility Type	
N/A	Any Obstructions?	N/A			N/A
	Obstruction Type		Yes	Surface Condition? (G/P)	Good
			N/A	Curb Slope (%)	2.5

Remove & Replace Entire Ramp.

R304.5.3

\$ 1600.00
