# Access Compliance Report

## Public Rights-of-Way

| Intersection ID: 11308 | Main Street: CARDIFF_AV | Cross Street: SPRINGWAY_DR | Location: SW |
| ADA ID: 09BBABC5BB7A | Ramp Type: PerpDiag | Initial Pass/Fail: Fail | Overall Compliance: No |

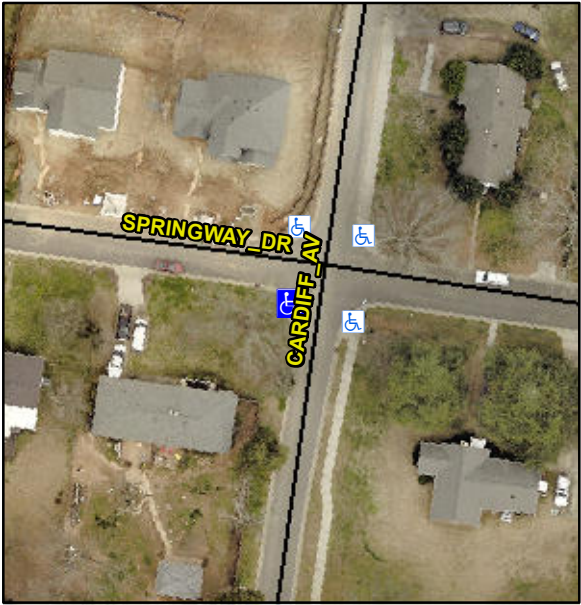
| Codes/Mitigation Info/Possible Solution | | | Field Measurements/Component Compliance | | |
|---|---|---|---|---|---|
| | <b>Remove &amp; Replace Curb Ramp With Two New Directional Ramps or Equivalent.</b> | | <b>No</b> | Ramp Length (in) | <b>62.0</b> |
| | | | <b>No</b> | Ramp Width (in) | <b>44.0</b> |
| <p>Surveyor Notes:</p> <p><b>N/A</b></p> <p>PROW/ADA:</p> <p><b>Not Found, R304.5.1, R304.2.2</b></p> | | | <b>N/A</b> | Flare Type RT | <b>N/A</b> |
| | | | <b>N/A</b> | Surface Condition? (G/P) | <b>Good</b> |

| Codes/Mitigation Info/Possible Solution | | | Field Measurements/Component Compliance | | |
|---|---|---|---|---|---|
| Total Cost: | | \$ 3200.00 | | | |
