# Access Compliance Report

## Public Rights-of-Way

### (Curb Ramps)

Intersection ID: 15397	Main Street: N_WENDOVER_RD	Cross Street: N_WENDOVER_RD_RA	Location: NE
ADA ID: 09BCED12EC22	Ramp Type: Perp	Initial Pass/Fail: Fail	Overall Compliance: No
Severity Score: 8.75			
Codes/Mitigation Info/Possible Solution		Field Measurements/Component Compliance

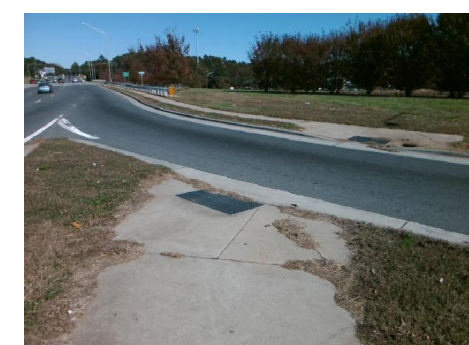
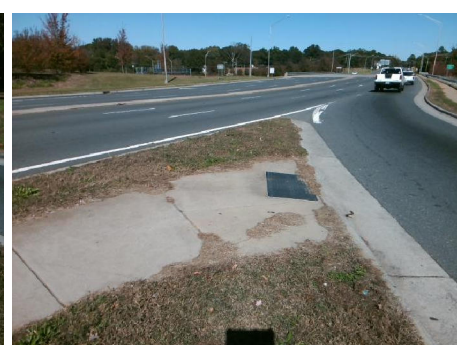
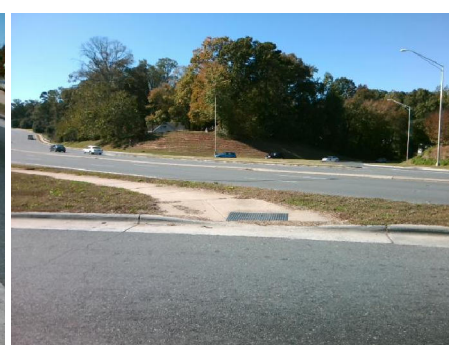
**Not Found, R304.5.1**

Compliance	Description	Data	Compliance	Description	Data
N/A	Ramp Length (in)	73.0	Yes	Ramp Slope (%)	6.3
No	Ramp Width (in)	41.0	Yes	Ramp XSlope (%)	0.9
N/A	Flare Type LT	N/A	N/A	Flare Type RT	N/A
N/A	Flare Slope LT (%)	N/A	N/A	Flare Slope RT (%)	N/A
N/A	Flare Traversable LT?	N/A	N/A	Flare Traversable RT?	N/A
N/A	Landing Length (in)	N/A	N/A	DWS Provided?	N/A
N/A	Landing Width (in)	N/A	N/A	DWS Contrast?	N/A
N/A	Landing Slope (%)	N/A	N/A	DWS Length (in)	N/A
N/A	Landing X Slope (%)	N/A	N/A	DWS Full Width?	N/A
N/A	Landing Curb? (Y/N)	N/A	N/A	DWS Offset (in)	N/A
N/A	Shared Landing?	N/A			
N/A	Gutter Ponding?	N/A	N/A	Gutter Slope (%)	N/A
N/A	Gutter Lip Ht (in)	N/A	N/A	Gutter X Slope (%)	N/A
N/A	Painted X Walk1?	No	N/A	Painted X Walk2?	N/A
	X Walk 1 Direction	To E		X Walk 2 Direction	N/A
N/A	X Walk 1 Width (in)	N/A	N/A	X Walk 2 Width (in)	N/A
	X Walk 1 Slope (%)	3.7		X Walk 2 Slope (%)	N/A
	X Walk 1 X Slope (%)	0.8		X Walk 2 X Slope (%)	N/A

N/A	Ramp inside XWalk1?	N/A	N/A	Ramp inside XWalk2?	N/A
	Road Slope (%)	N/A	N/A	Clear Space?	N/A
	Road X Slope (%)	N/A	N/A	Clear Space to XWalk (in)	N/A
N/A	Any Obstructions?	N/A	N/A	Storm Grate/Utility Hazard?	N/A
	Obstruction Type			Storm Grate/Utility Type	
		N/A			N/A
			Yes	Surface Condition? (G/P)	Good

**Remove & Replace Entire Ramp.**

Total Cost: \$ 1850.00
