Access Compliance Report

Public Rights-of-Way

(Curb Ramps)

Intersection ID: 19725	Main Street: COLONY_RD	Cross Street: SHARON_PY	Location:	N
ADA ID: 09BF59576D3B	Ramp Type: PerpDiag	Initial Pass/Fail: Fail	Overall Compliance: No	Severity Score: 12.5

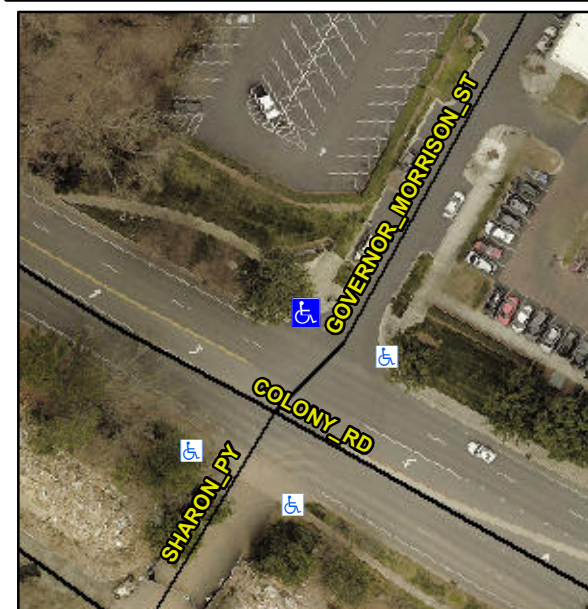
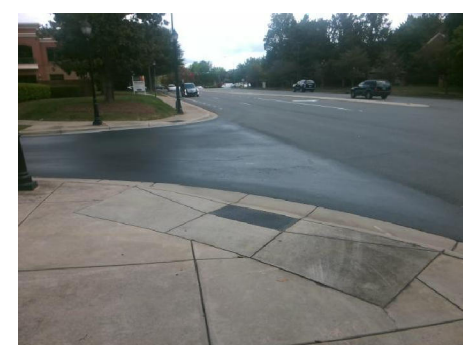
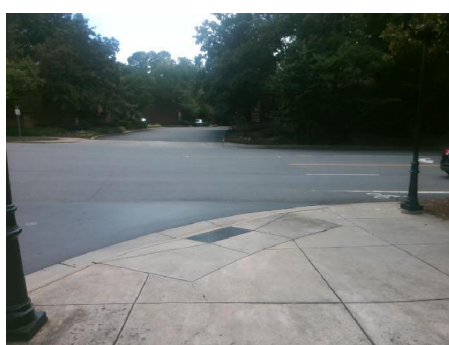
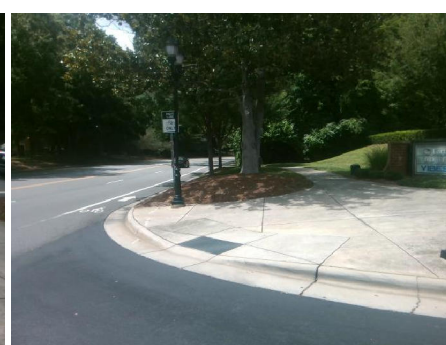
Not Found, R304.5.3

Compliance	Description	Data	Compliance	Description	Data
N/A	Ramp Length (in)	60.0	Yes	Ramp Slope (%)	8.0
Yes	Ramp Width (in)	48.0	No	Ramp XSlope (%)	6.1
N/A	Flare Type LT	N/A	N/A	Flare Type RT	N/A
N/A	Flare Slope LT (%)	N/A	N/A	Flare Slope RT (%)	N/A
N/A	Flare Traversable LT?	N/A	N/A	Flare Traversable RT?	N/A
N/A	Landing Length (in)	N/A	N/A	DWS Provided?	N/A
N/A	Landing Width (in)	N/A	N/A	DWS Contrast?	N/A
N/A	Landing Slope (%)	N/A	N/A	DWS Length (in)	N/A
N/A	Landing X Slope (%)	N/A	N/A	DWS Full Width?	N/A
N/A	Landing Curb? (Y/N)	N/A	N/A	DWS Offset (in)	N/A
N/A	Shared Landing?	N/A			
N/A	Gutter Ponding?	N/A	N/A	Gutter Slope (%)	N/A
N/A	Gutter Lip Ht (in)	N/A	N/A	Gutter X Slope (%)	N/A
N/A	Painted X Walk1?	No	N/A	Painted X Walk2?	No
	X Walk 1 Direction	To SW		X Walk 2 Direction	To SE
N/A	X Walk 1 Width (in)	N/A	N/A	X Walk 2 Width (in)	N/A
	X Walk 1 Slope (%)	4.2		X Walk 2 Slope (%)	0.0
	X Walk 1 X Slope (%)	2.2		X Walk 2 X Slope (%)	4.3

N/A	Ramp inside XWalk1?	N/A	N/A	Ramp inside XWalk2?	N/A
	Road Slope (%)	5.8	N/A	Clear Space?	N/A
	Road X Slope (%)	1.5	N/A	Clear Space to XWalk (in)	N/A
N/A	Any Obstructions?	N/A	N/A	Storm Grate/Utility Hazard?	N/A
	Obstruction Type			Storm Grate/Utility Type	
		N/A			N/A
			Yes	Surface Condition? (G/P)	Good

Remove & Replace Curb Ramp With Two New Directional Ramps or Equivalent.
