## **Access Compliance Report Public Rights-of-Way** (Curb Ramps)

Intersection ID: 52450 Main Street: TRANQUIL\_OAK\_PL **Cross Street: MOSS LN** Location: SW ADA ID: 09C09F5F9866 Ramp Type: BlendTrans1 Initial Pass/Fail: Fail **Overall Compliance: No Severity Score:** 1.25

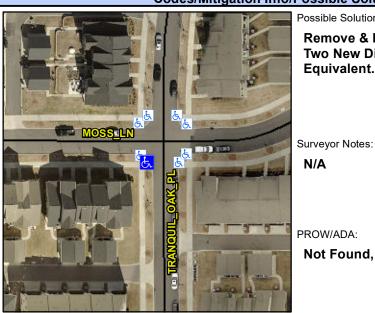
Compliance         Description         Data           N/A         Ramp Length (in)         59.0           Yes         Ramp Width (in)         65.0           N/A         Flare Type LT         N/A           N/A         Flare Slope LT (%)         N/A	Yes No N/A N/A N/A	BlendTrans Slope (%) BlendTrans XSlope (%) Flare Type RT Flare Slope RT (%)	3.2 3.0 N/A N/A
Yes Ramp Width (in) 65.0  N/A Flare Type LT N/A	No N/A N/A	BlendTrans XSlope (%) Flare Type RT Flare Slope RT (%)	3.0 N/A
N/A Flare Type LT N/A	N/A N/A	Flare Type RT Flare Slope RT (%)	N/A
,,	N/A	Flare Slope RT (%)	
N/A Flare Slope LT (%) N/A			N/A
	N/A	EL T 11 DT0	
N/A Flare Traversable LT? N/A		Flare Traversable RT?	N/A
N/A Landing Length (in) N/A	N/A	DWS Provided?	N/A
N/A Landing Width (in) N/A	N/A	DWS Contrast?	N/A
N/A Landing Slope (%) N/A	N/A	DWS Length (in)	N/A
N/A Landing X Slope (%) N/A	N/A	DWS Full Width?	N/A
N/A Landing Curb? (Y/N) N/A	N/A	DWS Offset (in)	N/A

N/A Shared Landing? N/A			
N/A Gutter Ponding? N/A	N/A	Gutter Slope (%)	N/A
N/A Gutter Lip Ht (in) 1.0	N/A	Gutter X Slope (%)	N/A
N/A Painted X Walk1? No	N/A	Painted X Walk2?	N/A
X Walk 1 Direction To E		X Walk 2 Direction	N/A
X Walk 1 Width (in) N/A		X Walk 2 Width (in)	N/A
X Walk 1 Slope (%) 2.8		X Walk 2 Slope (%)	N/A
X Walk 1 X Slope (%) 2.7		X Walk 2 X Slope (%)	N/A
N/A Ramp inside XWalk1? N/A	N/A	Ramp inside XWalk2?	N/A
Road Slope (%) 2.7		Clear Space?	N/A
Road X Slope (%) 2.8	N/A	Clear Space to XWalk (in)	N/A
N/A Any Obstructions? N/A	N/A	Storm Grate/Utility Hazard?	N/A
Obstruction Type		Storm Grate/Utility Type	
N/A			N/A
	Yes	Surface Condition? (G/P)	Good
	No	Curb Slope (%)	6.6

TRANQUIL OAK PL Street 1 Name StopSign Stop Condition-Street 1 Street 2 Name N/A Stop Condition-Street 2 N/A Remove & Replace Curb Ramp With **Two New Directional Ramps or** Equivalent.

Not Found, R304.5.3

3200.00
