Access Compliance Report

Public Rights-of-Way

(Curb Ramps)

Intersection ID: 14383	Main Street: CLEVELAND_AV	Cross Street: E TREMONT AV	Location: W
ADA ID: 09C29D0EE5CF	Ramp Type: PerpDiag	Initial Pass/Fail: Fail	Overall Compliance: No
		Severity Score: 12.5

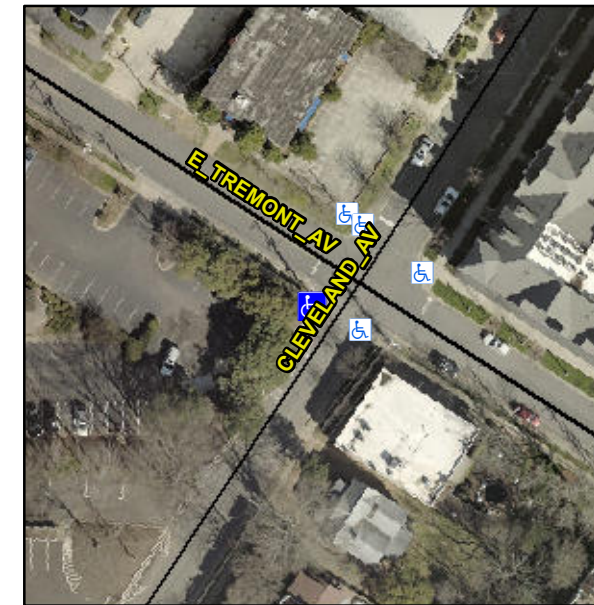
Not Found, R304.2.2

Compliance	Description	Data	Compliance	Description	Data
N/A	Ramp Length (in)	52.0	No	Ramp Slope (%)	10.1
Yes	Ramp Width (in)	48.0	Yes	Ramp XSlope (%)	1.9
N/A	Flare Type LT	N/A	N/A	Flare Type RT	N/A
N/A	Flare Slope LT (%)	N/A	N/A	Flare Slope RT (%)	N/A
N/A	Flare Traversable LT?	N/A	N/A	Flare Traversable RT?	N/A
N/A	Landing Length (in)	N/A	N/A	DWS Provided?	N/A
N/A	Landing Width (in)	N/A	N/A	DWS Contrast?	N/A
N/A	Landing Slope (%)	N/A	N/A	DWS Length (in)	N/A
N/A	Landing X Slope (%)	N/A	N/A	DWS Full Width?	N/A
N/A	Landing Curb? (Y/N)	N/A	N/A	DWS Offset (in)	N/A
N/A	Shared Landing?	N/A			
N/A	Gutter Ponding?	N/A	N/A	Gutter Slope (%)	N/A
N/A	Gutter Lip Ht (in)	1.0	N/A	Gutter X Slope (%)	N/A
N/A	Painted X Walk1?	No	N/A	Painted X Walk2?	No
	X Walk 1 Direction	To SE		X Walk 2 Direction	To NE
N/A	X Walk 1 Width (in)	N/A	N/A	X Walk 2 Width (in)	N/A
	X Walk 1 Slope (%)	1.0		X Walk 2 Slope (%)	0.2
	X Walk 1 X Slope (%)	3.3		X Walk 2 X Slope (%)	1.2

N/A	Ramp inside XWalk1?	N/A	N/A	Ramp inside XWalk2?	N/A
	Road Slope (%)	0.9	N/A	Clear Space?	N/A
	Road X Slope (%)	2.4	N/A	Clear Space to XWalk (in)	N/A
N/A	Any Obstructions?	N/A	N/A	Storm Grate/Utility Hazard?	N/A
	Obstruction Type			Storm Grate/Utility Type	
		N/A			N/A
			Yes	Surface Condition? (G/P)	Good

Remove & Replace Curb Ramp With Two New Directional Ramps or Equivalent.

Total Cost: \$ 3200.00
