Access Compliance Report

Public Rights-of-Way

(Curb Ramps)

Intersection ID: 11318	Main Street: GRANDIN_RD	Cross Street: W_4TH_ST_EXT	Location: NE
ADA ID: 09C5B6B5BAAB	Ramp Type: Para	Initial Pass/Fail: Fail	Overall Compliance: No
Severity Score: 13.75			
Codes/Mitigation Info/Possible Solution		Field Measurements/Component Compliance

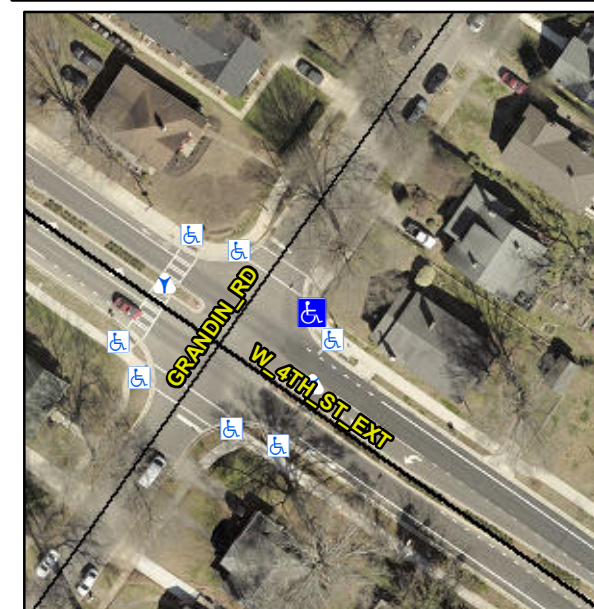
RT RP < 5%

R304.3.2, R304.5.3

Compliance	Description	Data	Compliance	Description	Data
N/A	Ramp Length LT (in)	120.0	N/A	Ramp Length RT (in)	39.0
Yes	Ramp Width LT (in)	122.0	Yes	Ramp Width RT (in)	112.0
No	Ramp Slope LT (%)	8.6	Yes	Ramp Slope RT (%)	0.0
Yes	Ramp XSlope LT (%)	1.5	No	Ramp XSlope RT (%)	2.4
N/A	Landing Length (in)	N/A	N/A	DWS Provided?	N/A
N/A	Landing Width (in)	N/A	N/A	DWS Contrast?	N/A
N/A	Landing Slope (%)	N/A	N/A	DWS Length (in)	N/A
N/A	Landing X Slope (%)	N/A	N/A	DWS Full Width?	N/A
N/A	Landing Curb? (Y/N)	N/A	N/A	DWS Offset (in)	N/A
N/A	Shared Landing?	N/A			
N/A	Gutter Ponding?	N/A	N/A	Gutter Slope (%)	N/A
N/A	Gutter Lip Ht (in)	N/A	N/A	Gutter X Slope (%)	N/A
N/A	Painted X Walk1?	No	N/A	Painted X Walk2?	N/A
	X Walk 1 Direction	To NW		X Walk 2 Direction	N/A
N/A	X Walk 1 Width (in)	N/A	N/A	X Walk 2 Width (in)	N/A
	X Walk 1 Slope (%)	0.4		X Walk 2 Slope (%)	N/A
	X Walk 1 X Slope (%)	2.5		X Walk 2 X Slope (%)	N/A
N/A	Ramp inside XWalk1?	N/A	N/A	Ramp inside XWalk2?	N/A

Road Slope (%)	N/A	N/A	Clear Space?	N/A
	Road X Slope (%)	N/A	N/A	Clear Space to XWalk (in)	N/A
N/A	Any Obstructions?	N/A	N/A	Storm Grate/Utility Hazard?	N/A
	Obstruction Type			Storm Grate/Utility Type	
		N/A			N/A
			Yes	Surface Condition? (G/P)	Good
			N/A	Curb Slope (%)	0.2

Remove & Replace Entire Ramp.
