Access Compliance Report

Public Rights-of-Way

(Curb Ramps)

Intersection ID: 3583	Main Street: ARDEN_GATE_LN	Cross Street: TREYMORE_LN	Location: W
ADA ID: 09CCA33C4B3D	Ramp Type: Perp	Initial Pass/Fail: Fail	Overall Compliance: No
Severity Score: 1.25			
Codes/Mitigation Info/Possible Solution		Field Measurements/Component Compliance

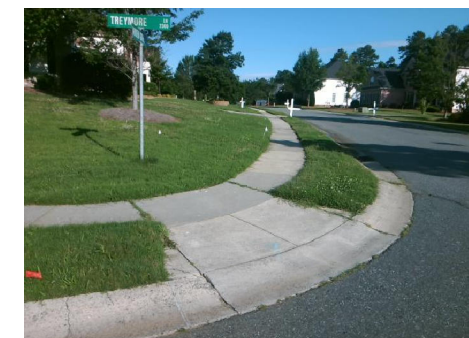
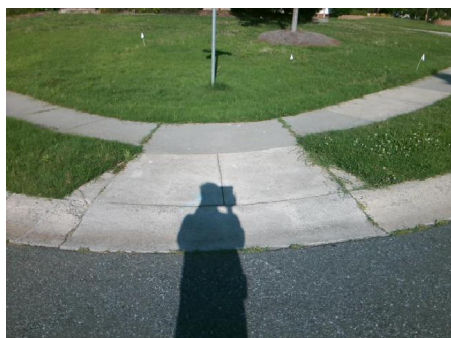
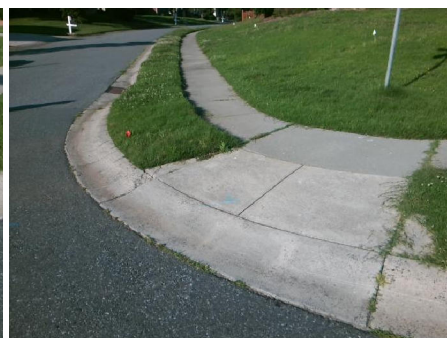
Not Found, R304.5.3

Compliance	Description	Data	Compliance	Description	Data
N/A	Ramp Length (in)	47.0	Yes	Ramp Slope (%)	6.5
Yes	Ramp Width (in)	63.0	No	Ramp XSlope (%)	5.0
N/A	Flare Type LT	N/A	N/A	Flare Type RT	N/A
N/A	Flare Slope LT (%)	N/A	N/A	Flare Slope RT (%)	N/A
N/A	Flare Traversable LT?	N/A	N/A	Flare Traversable RT?	N/A
N/A	Landing Length (in)	N/A	N/A	DWS Provided?	N/A
N/A	Landing Width (in)	N/A	N/A	DWS Contrast?	N/A
N/A	Landing Slope (%)	N/A	N/A	DWS Length (in)	N/A
N/A	Landing X Slope (%)	N/A	N/A	DWS Full Width?	N/A
N/A	Landing Curb? (Y/N)	N/A	N/A	DWS Offset (in)	N/A
N/A	Shared Landing?	N/A			
N/A	Gutter Ponding?	N/A	N/A	Gutter Slope (%)	N/A
N/A	Gutter Lip Ht (in)	N/A	N/A	Gutter X Slope (%)	N/A
N/A	Painted X Walk1?	No	N/A	Painted X Walk2?	N/A
	X Walk 1 Direction	To SE		X Walk 2 Direction	N/A
N/A	X Walk 1 Width (in)	N/A	N/A	X Walk 2 Width (in)	N/A
	X Walk 1 Slope (%)	0.7		X Walk 2 Slope (%)	N/A
	X Walk 1 X Slope (%)	1.2		X Walk 2 X Slope (%)	N/A

N/A	Ramp inside XWalk1?	N/A	N/A	Ramp inside XWalk2?	N/A
	Road Slope (%)	N/A	N/A	Clear Space?	N/A
	Road X Slope (%)	N/A	N/A	Clear Space to XWalk (in)	N/A
N/A	Any Obstructions?	N/A	N/A	Storm Grate/Utility Hazard?	N/A
	Obstruction Type			Storm Grate/Utility Type	
		N/A			N/A
			Yes	Surface Condition? (G/P)	Good

Remove & Replace Entire Ramp.
