Intersection ID: 49348	Main Street: HONEY_FIG_RD	Cross Street: FIRESPIKE_RD	Location:	NE
ADA ID: 09D20959335E	Ramp Type: Perp	Initial Pass/Fail: Fail	Overall Compliance: No	Severity Score: 8.75

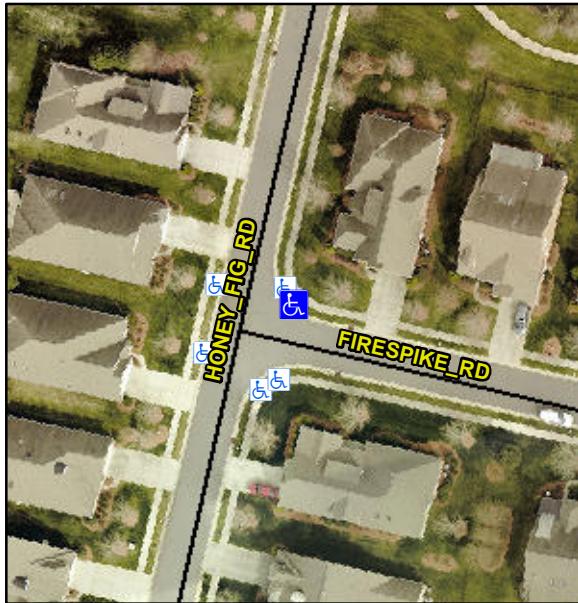
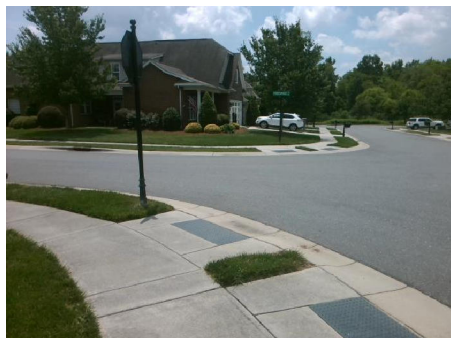
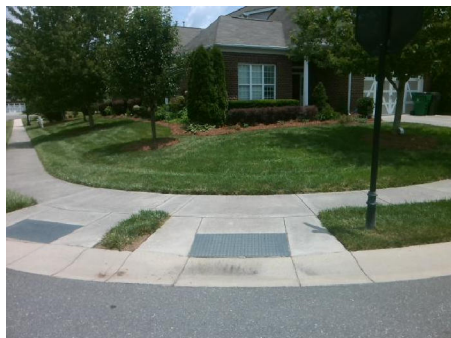
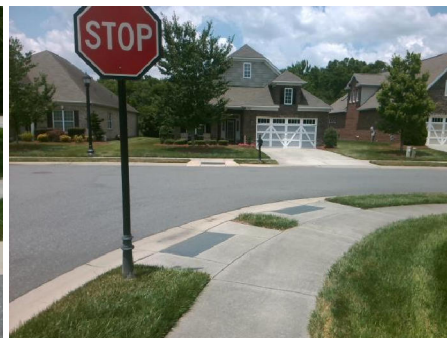
R304.5.1

Possible Solutions:			Compliance	Description	Data	Compliance	Description	Data
Remove & Replace Entire Ramp.	N/A	Ramp Length (in)	48.0	Yes	Ramp Slope (%)	7.9		
	No	Ramp Width (in)	47.0	Yes	Ramp XSlope (%)	0.0		
	N/A	Flare Type LT	N/A	N/A	Flare Type RT	N/A		
	N/A	Flare Slope LT (%)	N/A	N/A	Flare Slope RT (%)	N/A		
	N/A	Flare Traversable LT?	N/A	N/A	Flare Traversable RT?	N/A		
	N/A	Landing Length (in)	N/A	N/A	DWS Provided?	N/A		
	N/A	Landing Width (in)	N/A	N/A	DWS Contrast?	N/A		
	N/A	Landing Slope (%)	N/A	N/A	DWS Length (in)	N/A		
	N/A	Landing X Slope (%)	N/A	N/A	DWS Full Width?	N/A		
	N/A	Landing Curb? (Y/N)	N/A	N/A	DWS Offset (in)	N/A		
	N/A	Shared Landing?	N/A					
	Surveyor Notes: N/A	N/A	Gutter Ponding?	N/A	N/A	Gutter Slope (%)	N/A	
N/A		Gutter Lip Ht (in)	N/A	N/A	Gutter X Slope (%)	N/A		
N/A		Painted X Walk1?	No	N/A	Painted X Walk2?	N/A		
		X Walk 1 Direction	To SW		X Walk 2 Direction	N/A		
N/A		X Walk 1 Width (in)	N/A	N/A	X Walk 2 Width (in)	N/A

X Walk 1 Slope (%)	0.6		X Walk 2 Slope (%)	N/A		
		X Walk 1 X Slope (%)	0.8		X Walk 2 X Slope (%)	N/A		
N/A		Ramp inside XWalk1?	N/A	N/A	Ramp inside XWalk2?	N/A		
		Road Slope (%)	N/A	N/A	Clear Space?	N/A		
		Road X Slope (%)	N/A	N/A	Clear Space to XWalk (in)	N/A		
N/A		Any Obstructions?	N/A	N/A	Storm Grate/Utility Hazard?	N/A		
PROW/ADA: R304.5.1			Obstruction Type			Storm Grate/Utility Type		
			N/A			N/A		
Total Cost:		\$	1850.00	Yes	Surface Condition? (G/P)	Good

Remove & Replace Entire Ramp.
