Access Compliance Report

Public Rights-of-Way

(Curb Ramps)

Intersection ID: 27176	Main Street: SPRING_ST	Cross Street: KNOX_AV	Location:	N
ADA ID: 09D336C769FD	Ramp Type: Perp	Initial Pass/Fail: Fail	Overall Compliance: No	Severity Score: 33.75
Codes/Mitigation Info/Possible Solution		Field Measurements/Component Compliance

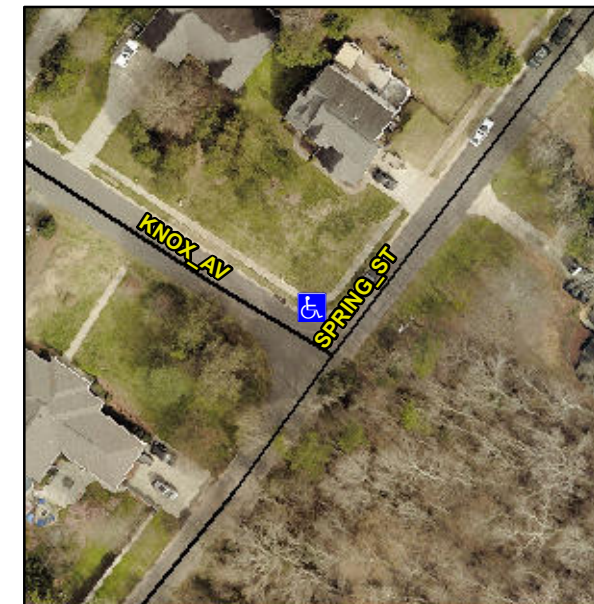
R304.5.1, R304.5.3

Compliance	Description	Data	Compliance	Description	Data
N/A	Ramp Length (in)	48.5	Yes	Ramp Slope (%)	7.1
No	Ramp Width (in)	38.5	No	Ramp XSlope (%)	10.7
N/A	Flare Type LT	N/A	N/A	Flare Type RT	N/A
N/A	Flare Slope LT (%)	N/A	N/A	Flare Slope RT (%)	N/A
N/A	Flare Traversable LT?	N/A	N/A	Flare Traversable RT?	N/A
N/A	Landing Length (in)	N/A	N/A	DWS Provided?	N/A
N/A	Landing Width (in)	N/A	N/A	DWS Contrast?	N/A
N/A	Landing Slope (%)	N/A	N/A	DWS Length (in)	N/A
N/A	Landing X Slope (%)	N/A	N/A	DWS Full Width?	N/A
N/A	Landing Curb? (Y/N)	N/A	N/A	DWS Offset (in)	N/A
N/A	Shared Landing?	N/A			
N/A	Gutter Ponding?	N/A	N/A	Gutter Slope (%)	N/A
N/A	Gutter Lip Ht (in)	N/A	N/A	Gutter X Slope (%)	N/A
N/A	Painted X Walk1?	No	N/A	Painted X Walk2?	N/A
	X Walk 1 Direction	To W		X Walk 2 Direction	N/A
N/A	X Walk 1 Width (in)	N/A	N/A	X Walk 2 Width (in)	N/A
	X Walk 1 Slope (%)	0.6		X Walk 2 Slope (%)	N/A
	X Walk 1 X Slope (%)	1.7		X Walk 2 X Slope (%)	N/A

N/A	Ramp inside XWalk1?	N/A	N/A	Ramp inside XWalk2?	N/A
	Road Slope (%)	N/A	N/A	Clear Space?	N/A
	Road X Slope (%)	N/A	N/A	Clear Space to XWalk (in)	N/A
N/A	Any Obstructions?	N/A	N/A	Storm Grate/Utility Hazard?	N/A
	Obstruction Type			Storm Grate/Utility Type	
		N/A			N/A
			Yes	Surface Condition? (G/P)	Good

Remove & Replace Entire Ramp.
