Access Compliance Report

Public Rights-of-Way

(Curb Ramps)

Intersection ID: 44164	Main Street: MEADOW_KNOLL_DR	Cross Street: COCHRANE_DR	Location: SE
ADA ID: 09EE3750FF02	Ramp Type: PerpDiag	Initial Pass/Fail: Fail	Overall Compliance: No
Severity Score: 46.25			
Codes/Mitigation Info/Possible Solution		Field Measurements/Component Compliance

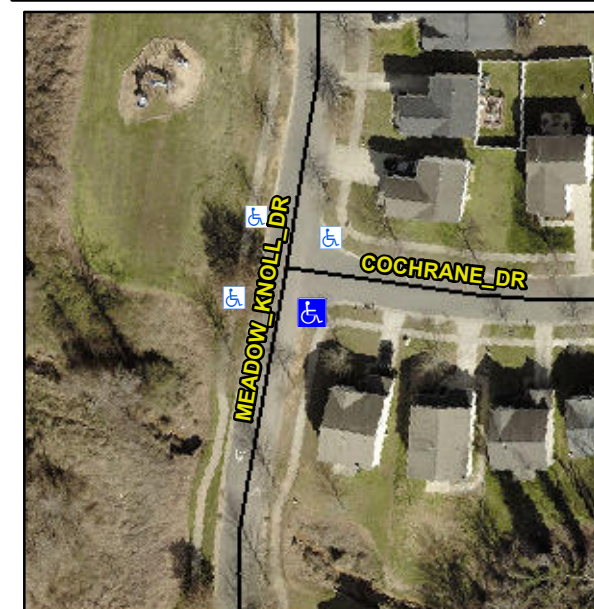
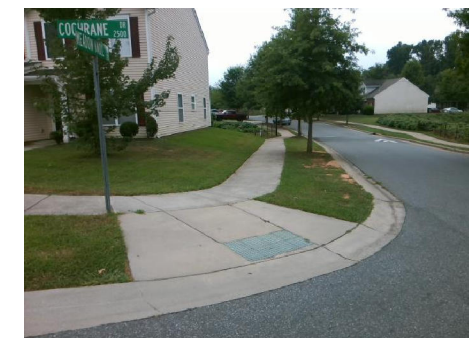
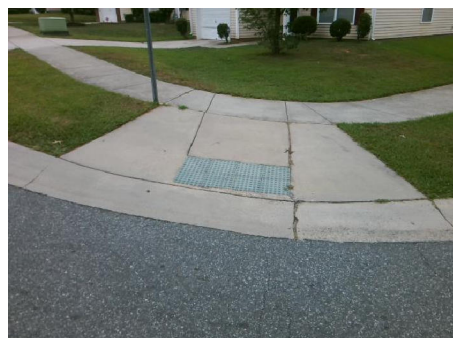
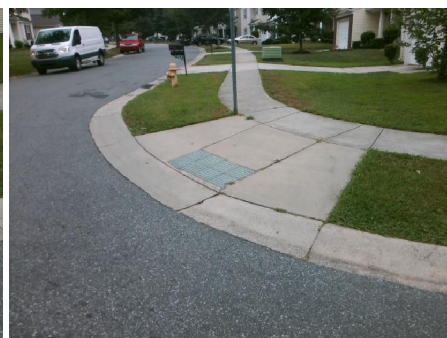
Not Found, R304.5.1, R304.2.2, R304.5.3

Compliance	Description	Data	Compliance	Description	Data
N/A	Ramp Length (in)	84.5	No	Ramp Slope (%)	11.4
No	Ramp Width (in)	47.0	No	Ramp XSlope (%)	8.6
N/A	Flare Type LT	N/A	N/A	Flare Type RT	N/A
N/A	Flare Slope LT (%)	N/A	N/A	Flare Slope RT (%)	N/A
N/A	Flare Traversable LT?	N/A	N/A	Flare Traversable RT?	N/A
N/A	Landing Length (in)	N/A	N/A	DWS Provided?	N/A
N/A	Landing Width (in)	N/A	N/A	DWS Contrast?	N/A
N/A	Landing Slope (%)	N/A	N/A	DWS Length (in)	N/A
N/A	Landing X Slope (%)	N/A	N/A	DWS Full Width?	N/A
N/A	Landing Curb? (Y/N)	N/A	N/A	DWS Offset (in)	N/A
N/A	Shared Landing?	N/A			
N/A	Gutter Ponding?	N/A	N/A	Gutter Slope (%)	N/A
N/A	Gutter Lip Ht (in)	N/A	N/A	Gutter X Slope (%)	N/A
N/A	Painted X Walk1?	No	N/A	Painted X Walk2?	No
	X Walk 1 Direction	To N		X Walk 2 Direction	To W
N/A	X Walk 1 Width (in)	N/A	N/A	X Walk 2 Width (in)	N/A
	X Walk 1 Slope (%)	9.8		X Walk 2 Slope (%)	0.2
	X Walk 1 X Slope (%)	3.0		X Walk 2 X Slope (%)	7.8

N/A	Ramp inside XWalk1?	N/A	N/A	Ramp inside XWalk2?	N/A
	Road Slope (%)	8.6	N/A	Clear Space?	N/A
	Road X Slope (%)	6.5	N/A	Clear Space to XWalk (in)	N/A
N/A	Any Obstructions?	N/A	N/A	Storm Grate/Utility Hazard?	N/A
	Obstruction Type			Storm Grate/Utility Type	
		N/A			N/A
			Yes	Surface Condition? (G/P)	Good

Remove & Replace Curb Ramp With Two New Directional Ramps or Equivalent.
