Access Compliance Report

Public Rights-of-Way

(Curb Ramps)

Intersection ID: 30484	Main Street: GLORY_MEADOW_CT	Cross Street: PLANTERS_ROW_DR	Location: NE
ADA ID: 09F46B8F8E37	Ramp Type: PerpDiag	Initial Pass/Fail: Fail	Overall Compliance: No
Severity Score: 8.75			
Codes/Mitigation Info/Possible Solution		Field Measurements/Component Compliance

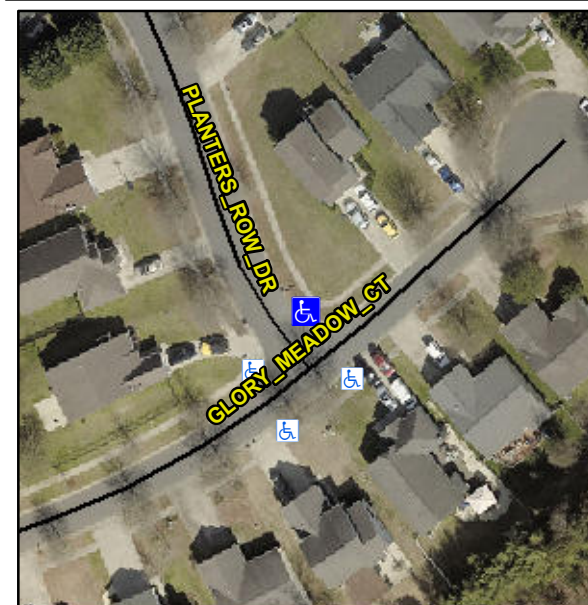
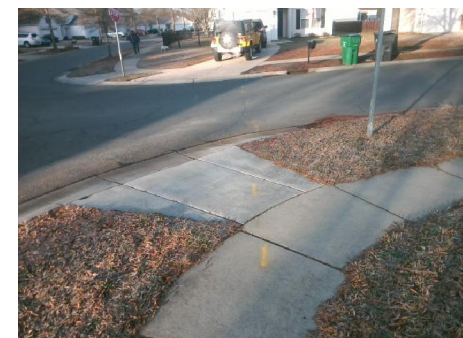
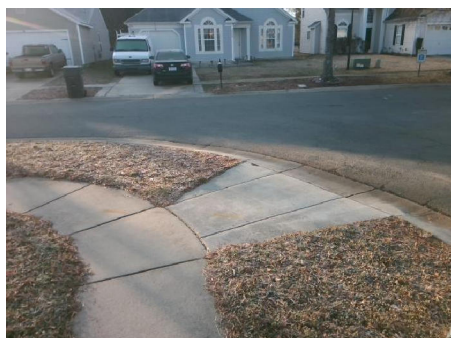
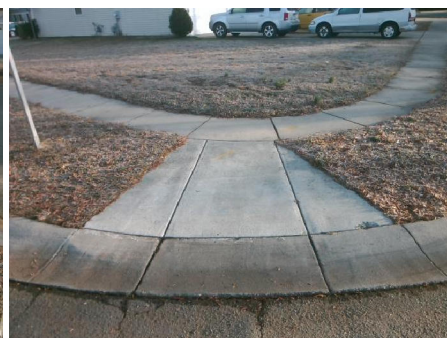
Not Found, R304.5.1

Compliance	Description	Data	Compliance	Description	Data
N/A	Ramp Length (in)	83.0	Yes	Ramp Slope (%)	6.5
No	Ramp Width (in)	36.5	Yes	Ramp XSlope (%)	0.3
N/A	Flare Type LT	N/A	N/A	Flare Type RT	N/A
N/A	Flare Slope LT (%)	N/A	N/A	Flare Slope RT (%)	N/A
N/A	Flare Traversable LT?	N/A	N/A	Flare Traversable RT?	N/A
N/A	Landing Length (in)	N/A	N/A	DWS Provided?	N/A
N/A	Landing Width (in)	N/A	N/A	DWS Contrast?	N/A
N/A	Landing Slope (%)	N/A	N/A	DWS Length (in)	N/A
N/A	Landing X Slope (%)	N/A	N/A	DWS Full Width?	N/A
N/A	Landing Curb? (Y/N)	N/A	N/A	DWS Offset (in)	N/A
N/A	Shared Landing?	N/A			
N/A	Gutter Ponding?	N/A	N/A	Gutter Slope (%)	N/A
N/A	Gutter Lip Ht (in)	N/A	N/A	Gutter X Slope (%)	N/A
N/A	Painted X Walk1?	No	N/A	Painted X Walk2?	No
	X Walk 1 Direction	To SW		X Walk 2 Direction	To SE
N/A	X Walk 1 Width (in)	N/A	N/A	X Walk 2 Width (in)	N/A
	X Walk 1 Slope (%)	1.1		X Walk 2 Slope (%)	1.6
	X Walk 1 X Slope (%)	0.1		X Walk 2 X Slope (%)	0.7

N/A	Ramp inside XWalk1?	N/A	N/A	Ramp inside XWalk2?	N/A
	Road Slope (%)	1.5	N/A	Clear Space?	N/A
	Road X Slope (%)	0.0	N/A	Clear Space to XWalk (in)	N/A
N/A	Any Obstructions?	N/A	N/A	Storm Grate/Utility Hazard?	N/A
	Obstruction Type			Storm Grate/Utility Type	
		N/A			N/A
		Yes		Surface Condition? (G/P)	Good

Possible Solutions:

Remove & Replace Curb Ramp With Two New Directional Ramps or Equivalent.
