Access Compliance Report

Public Rights-of-Way

(Curb Ramps)

Intersection ID: 47469	Main Street: KALISPELL_LN	Cross Street: ELENDIL_LN	Location: NE
ADA ID: 0A06152F51D1	Ramp Type: BlendTrans1	Initial Pass/Fail: Fail	Overall Compliance: No
		Severity Score: 10

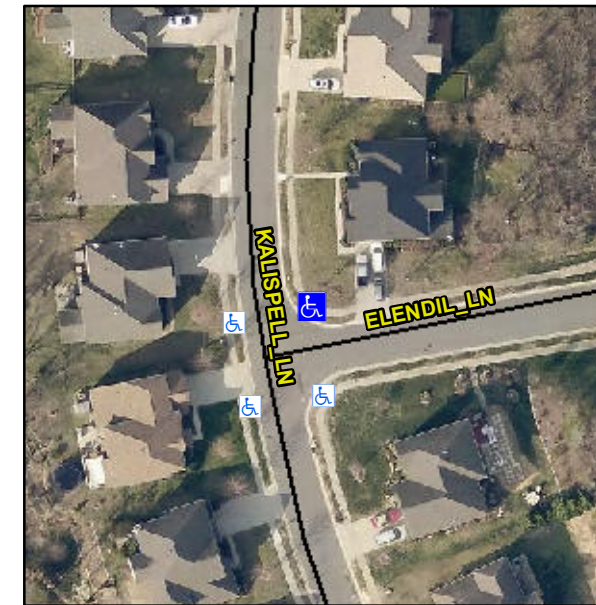
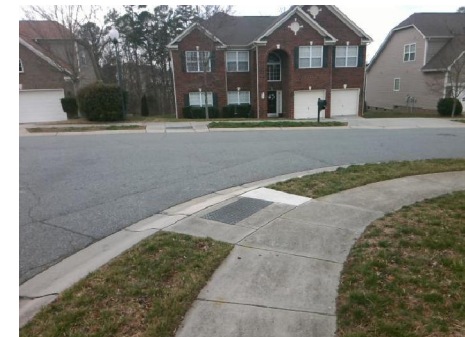
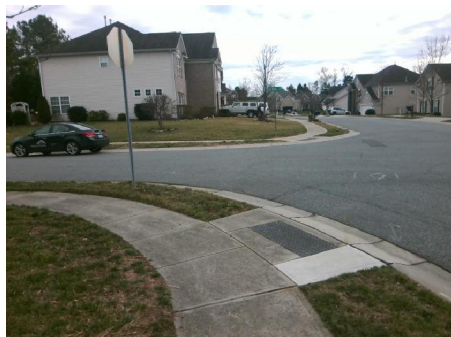
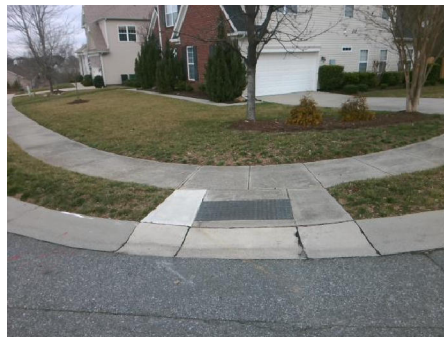
Not Found, R304.5.1, R304.5.3

Compliance	Description	Data	Compliance	Description	Data
N/A	Ramp Length (in)	46.5	Yes	BlendTrans Slope (%)	0.9
No	Ramp Width (in)	47.0	No	BlendTrans XSlope (%)	3.1
N/A	Flare Type LT	N/A	N/A	Flare Type RT	N/A
N/A	Flare Slope LT (%)	N/A	N/A	Flare Slope RT (%)	N/A
N/A	Flare Traversable LT?	N/A	N/A	Flare Traversable RT?	N/A
N/A	Landing Length (in)	N/A	N/A	DWS Provided?	N/A
N/A	Landing Width (in)	N/A	N/A	DWS Contrast?	N/A
N/A	Landing Slope (%)	N/A	N/A	DWS Length (in)	N/A
N/A	Landing X Slope (%)	N/A	N/A	DWS Full Width?	N/A
N/A	Landing Curb? (Y/N)	N/A	N/A	DWS Offset (in)	N/A
N/A	Shared Landing?	N/A			
N/A	Gutter Ponding?	N/A	N/A	Gutter Slope (%)	N/A
N/A	Gutter Lip Ht (in)	N/A	N/A	Gutter X Slope (%)	N/A
N/A	Painted X Walk1?	No	N/A	Painted X Walk2?	No
	X Walk 1 Direction	To W		X Walk 2 Direction	To S
	X Walk 1 Width (in)	N/A		X Walk 2 Width (in)	N/A
	X Walk 1 Slope (%)	0.7		X Walk 2 Slope (%)	5.4
	X Walk 1 X Slope (%)	5.4		X Walk 2 X Slope (%)	0.7

N/A	Ramp inside XWalk1?	N/A	N/A	Ramp inside XWalk2?	N/A
	Road Slope (%)	2.5		Clear Space?	N/A
	Road X Slope (%)	6.8	N/A	Clear Space to XWalk (in)	N/A
N/A	Any Obstructions?	N/A	N/A	Storm Grate/Utility Hazard?	N/A
	Obstruction Type			Storm Grate/Utility Type	
		N/A			N/A
			Yes	Surface Condition? (G/P)	Good
			No	Curb Slope (%)	19.5

Remove & Replace Curb Ramp With Two New Directional Ramps or Equivalent.
