## Access Compliance Report Public Rights-of-Way (Curb Ramps)

Intersection ID: 41209 Main Str	section ID: 41209 Main Street: SACKETT WY C				ross Street: CLYMER_CT				
	Ramp Type: PerpDiag		Initial Pass/Fail: Fail Overall Compliance: No			Location: o Severity Score:	NW 21.25		
		initian r ac	<u>,,,,,</u>			21.20			
Codes/Mitigation Info/Possible Solution			Field Measurements/Component Compliance   Compliance Description Data						
	Possible Solutions:	-	Compliance Description			Data Compliance Description			
	Remove & Replace Curb Ramp W		I/A	Ramp Length (in)	49.0	Yes	Ramp Slope (%)	7.8	
	Two New Directional Ramps or Equivalent.	N	lo	Ramp Width (in)	45.5	No	Ramp XSlope (%)	6.4	
		N	I/A	Flare Type LT	N/A	N/A	Flare Type RT	N/A	
		N	I/A	Flare Slope LT (%)	N/A	N/A	Flare Slope RT (%)	N/A	
		N	I/A	Flare Traversable LT?	N/A	N/A	Flare Traversable RT?	N/A	
		N	I/A	Landing Length (in)	N/A	N/A	DWS Provided?	N/A	
	Surveyor Notes:	Ν	I/A	Landing Width (in)	N/A	N/A	DWS Contrast?	N/A

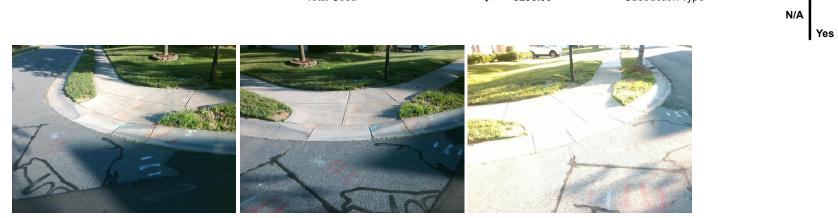
N/A	Ν	I/A	Landing Slope (%)	N/A	N/A	DWS Length (in)	N/A	
		Ν	I/A	Landing X Slope (%)	N/A	N/A	DWS Full Width?	N/A	
		Ν	I/A	Landing Curb? (Y/N)	N/A	N/A	DWS Offset (in)	N/A	
		Ν	I/A	Shared Landing?	N/A				
	PROW/ADA:	N	I/A	Gutter Ponding?	N/A	N/A	Gutter Slope (%)	N/A	
	Not Found, R304.5.1, R304.5.3	Ν	I/A	Gutter Lip Ht (in)	N/A	N/A	Gutter X Slope (%)	N/A	
	,,	Ν	I/A	Painted X Walk1?	No	N/A	Painted X Walk2?	No	
				X Walk 1 Direction	To S		X Walk 2 Direction	To E	
		Ν	I/A	X Walk 1 Width (in)	N/A	N/A	X Walk 2 Width (in)	N/A	
Street 1 Name CLYMER CT	_			X Walk 1 Slope (%)	3.3		X Walk 2 Slope (%)	4.4	
Stop Condition-Street 2 StopSign				X Walk 1 X Slope (%)	5.2		X Walk 2 X Slope (%)	4.2	
Street 2 Name SACKETT WY		Ν	I/A	Ramp inside XWalk1?	N/A	N/A	Ramp inside XWalk2?	N/A	
Stop Condition-Street 1 None				Road Slope (%)	6.6	N/A	Clear Space?	N/A	
				Road X Slope (%)	0.6	N/A	Clear Space to XWalk (in)	N/A	
		Ν	I/A	Any Obstructions?	N/A	N/A	Storm Grate/Utility Hazard?	N/A

Total Cost: \$ 32	00.00		Obstruction Type			Storm Grate/Utility Type		
	- ··· ··· ··· ··· ··· ··· ··· ··· ··· ·				N/A			N/A
