# Access Compliance Report

## Public Rights-of-Way

### (Curb Ramps)

Intersection ID: 2739	Main Street: BELL'S_MILL_DR	Cross Street: WINGMONT_DR	Location: SW
ADA ID: 0A35BBE4ED1E	Ramp Type: Perp	Initial Pass/Fail: Pass	Overall Compliance: No
Codes/Mitigation Info/Possible Solution		Field Measurements/Component Compliance

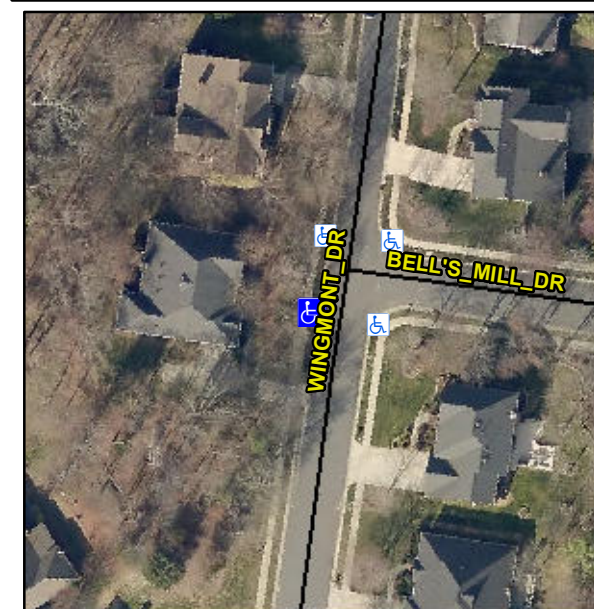
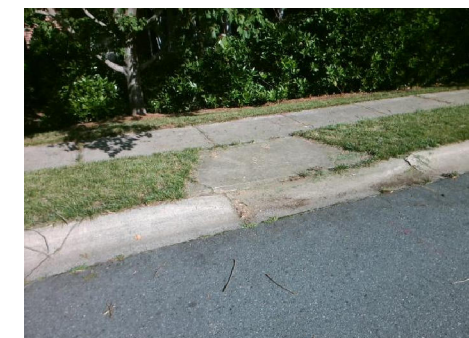
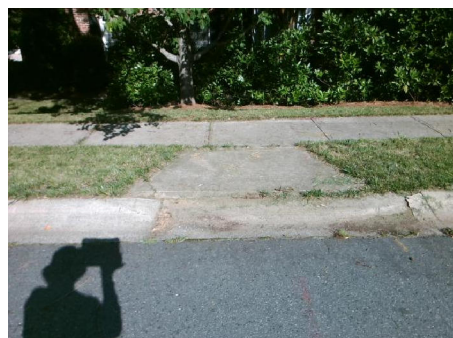
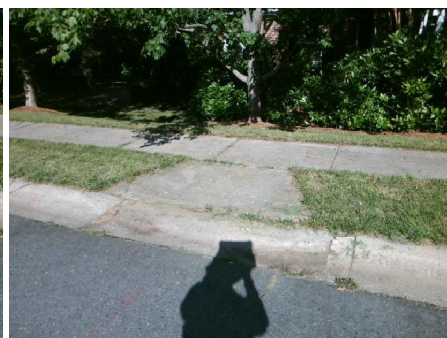
Compliance	Description	Data	Compliance	Description	Data
N/A	Ramp Length (in)	46.0	Yes	Ramp Slope (%)	5.2
Yes	Ramp Width (in)	58.0	Yes	Ramp XSlope (%)	0.9
N/A	Flare Type LT	Sloped	N/A	Flare Type RT	N/A
N/A	Flare Slope LT (%)	8.6	N/A	Flare Slope RT (%)	7.1
N/A	Flare Traversable LT?	No	N/A	Flare Traversable RT?	No
Yes	Landing Length (in)	48.0	No	DWS Provided?	No
Yes	Landing Width (in)	58.0	N/A	DWS Contrast?	No
Yes	Landing Slope (%)	0.1	N/A	DWS Length (in)	N/A
Yes	Landing X Slope (%)	0.5	N/A	DWS Full Width?	No
N/A	Landing Curb? (Y/N)	No	N/A	DWS Offset (in)	N/A
N/A	Shared Landing?	No			
No	Gutter Ponding?	Yes	Yes	Gutter Slope (%)	0.2
Yes	Gutter Lip Ht (in)	0.0	Yes	Gutter X Slope (%)	0.2
N/A	Painted X Walk1?	No	N/A	Painted X Walk2?	N/A
	X Walk 1 Direction	To E		X Walk 2 Direction	N/A
N/A	X Walk 1 Width (in)	N/A	N/A	X Walk 2 Width (in)	N/A
	X Walk 1 Slope (%)	4.8		X Walk 2 Slope (%)	N/A
	X Walk 1 X Slope (%)	0.4		X Walk 2 X Slope (%)	N/A

N/A	Ramp inside XWalk1?	N/A	N/A	Ramp inside XWalk2?	N/A
	Road Slope (%)	N/A	N/A	Clear Space?	Yes
	Road X Slope (%)	N/A	N/A	Clear Space to XWalk (in)	N/A
Yes	Any Obstructions?	No	Yes	Storm Grate/Utility Hazard?	No
	Obstruction Type			Storm Grate/Utility Type	
		N/A			N/A
			Yes	Surface Condition? (G/P)	Good

Possible Solutions:

**Remove & Replace Entire Ramp.**

**Not Found, R305, R302.7**

Total Cost: \$ 1850.00
